RESTORATION OF THE CLOCK MECHANISM'S DECORATIVE ARCH

Author:
KRIŠJĀNIS RIMŠĀNS master metalwork restorer,
 k.rimsans@inbox.lv
 Independent restorer

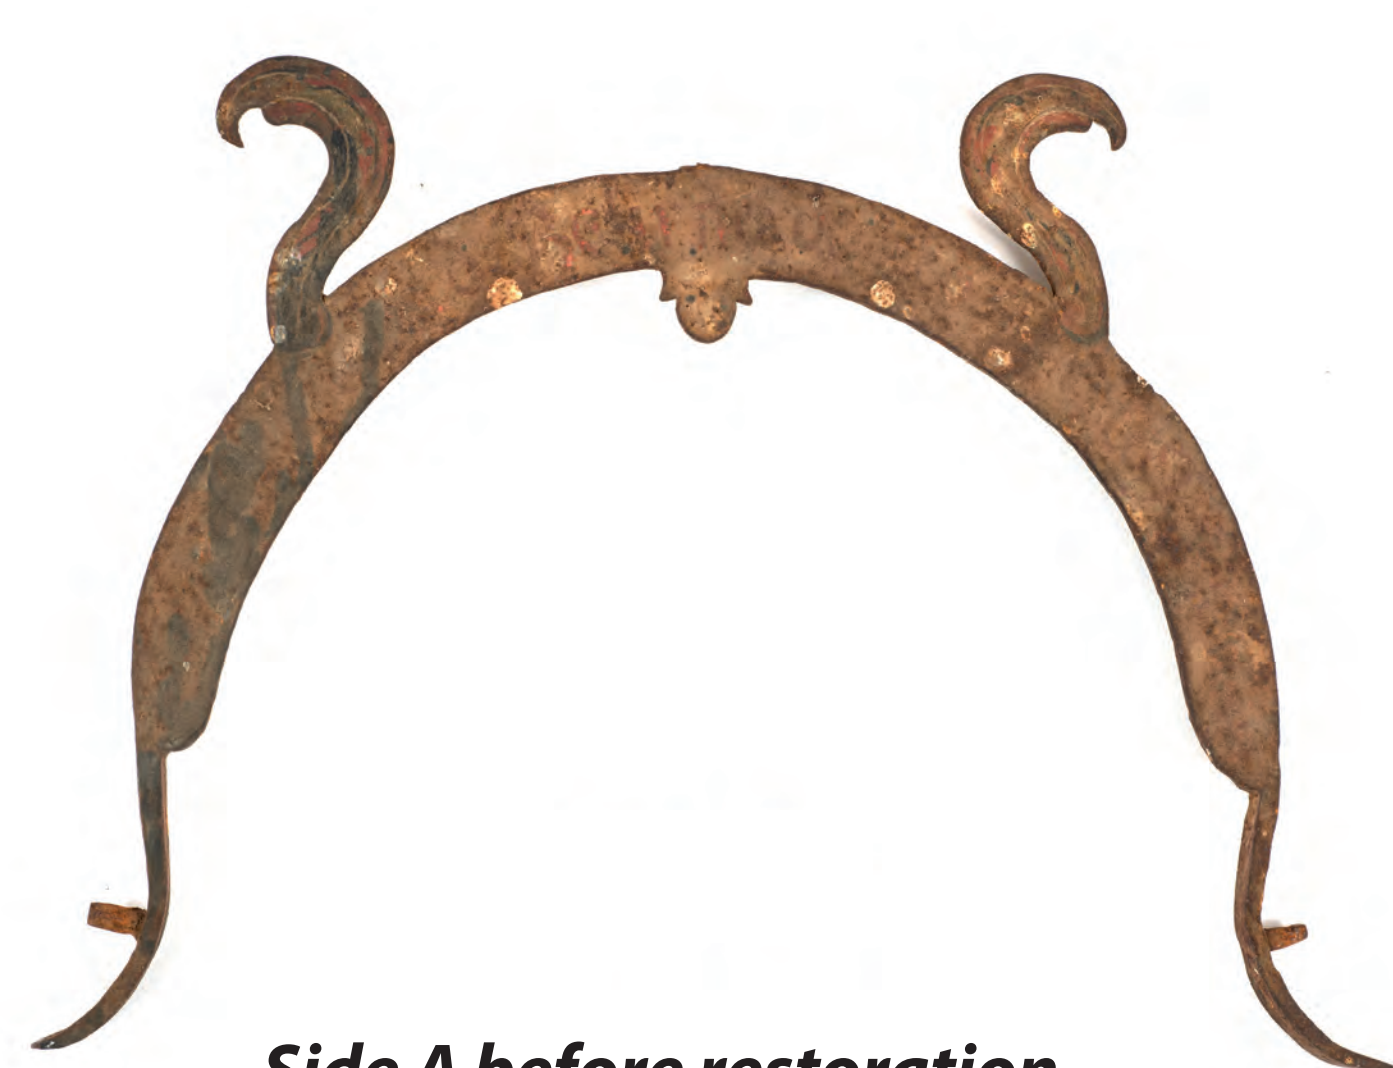
Side A before restoration

The metallic core of the object is stable and well preserved. The surface was covered with a layer of corrosion products and accumulated dirt, including bird droppings and tar run-offs, which may have fallen on the surface during roof repair or maintenance works. The arch is deformed in its central section, and the decorative central projection at the upper part is missing. The paint layer is layered with corrosion products and dirt; it is cracked, fragile, with local losses.

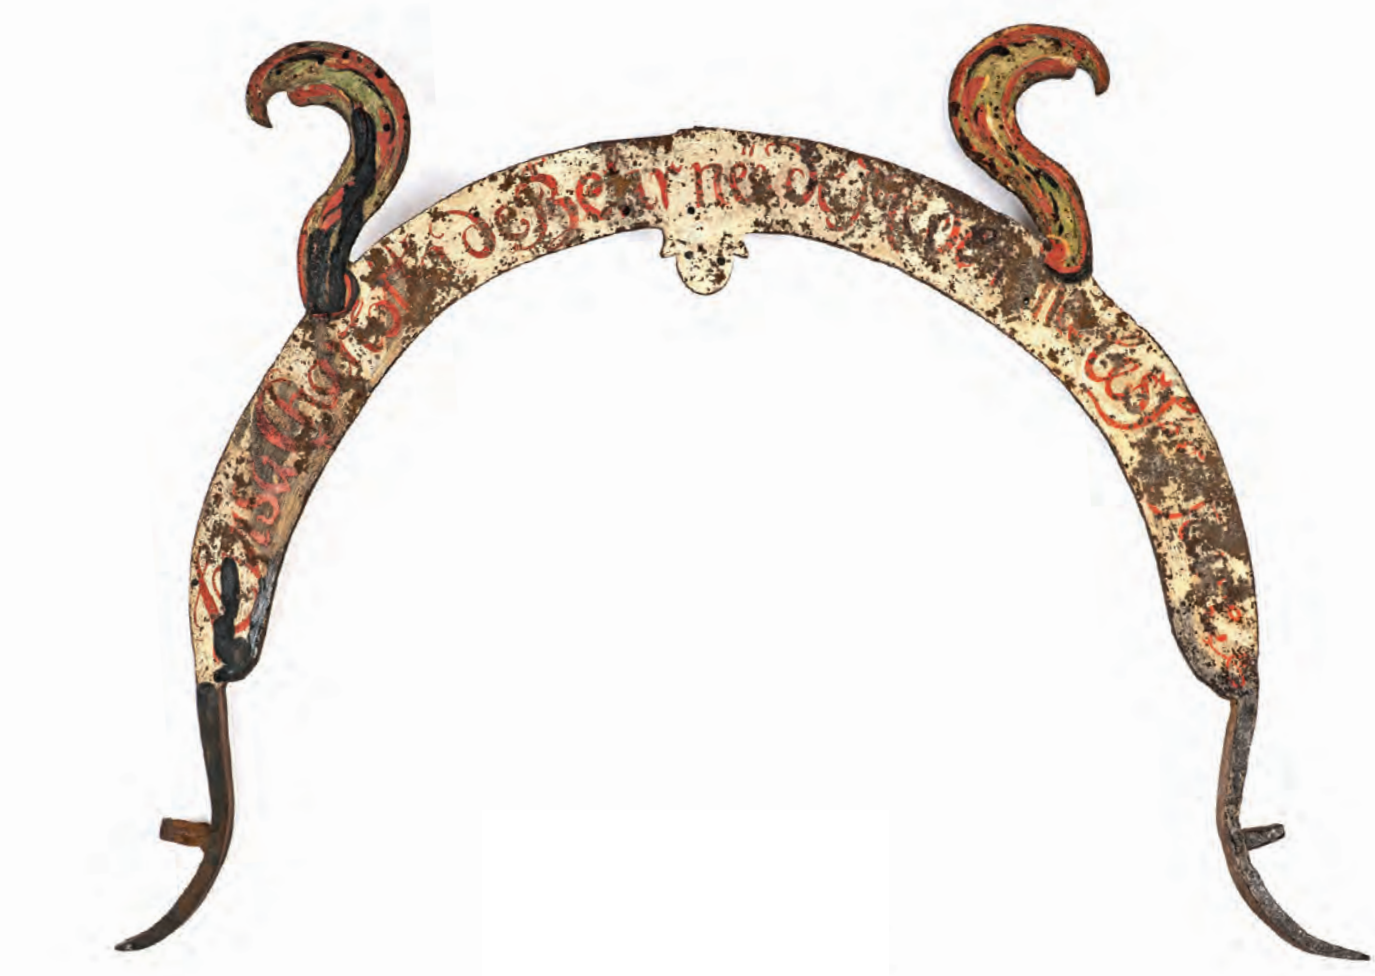
Side A after chemical treatment (Charlotte da Behr neé de Medem m'a lessés faire)

The aim of the conservation treatment was the reduction of corrosion products and the stabilization of the polychrome surface while preserving the maximum amount of original material. Areas with flaking paint were locally consolidated prior to further intervention. After consolidation, surface dirt and corrosion products were addressed. Several chemical cleaning agents were tested to identify the most effective and least invasive method. Cleaning was continued using (5%) phosphoric acid applied in compresses, which effectively reduced corrosion without causing paint leaching.

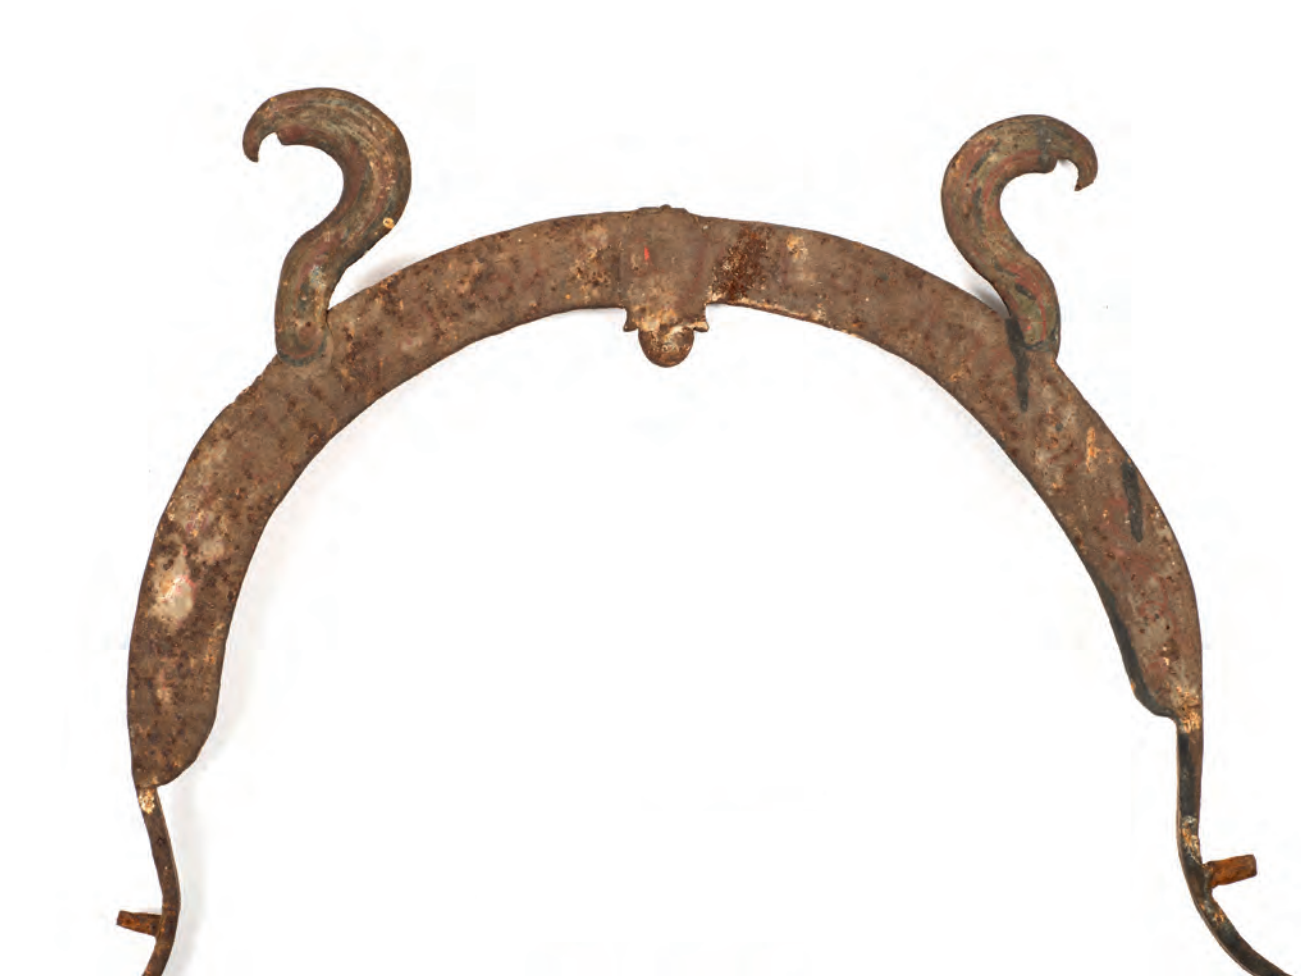
Side B before restoration

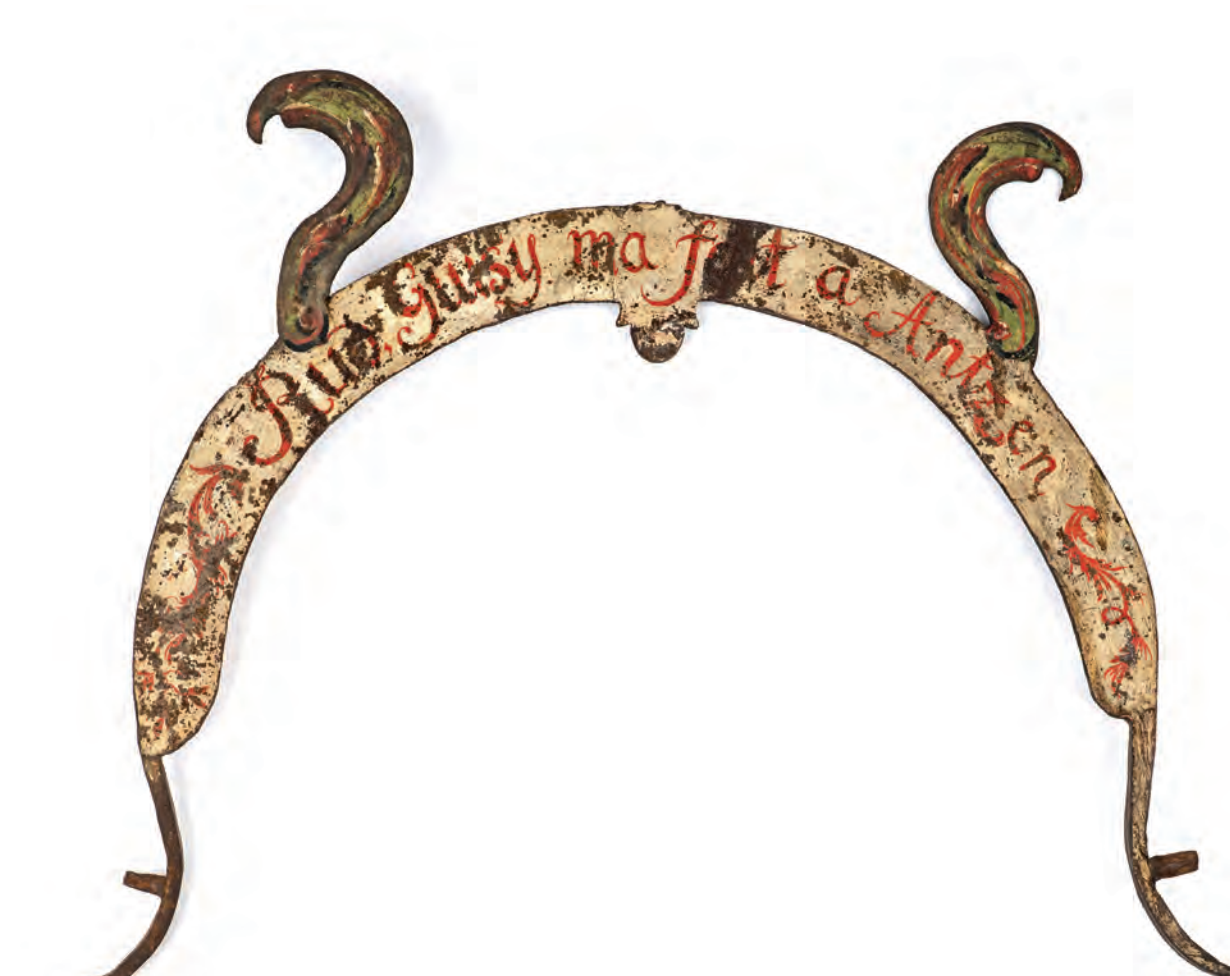
Side B after chemical treatment (Rud: Guisy ma fait 'a Anzen)

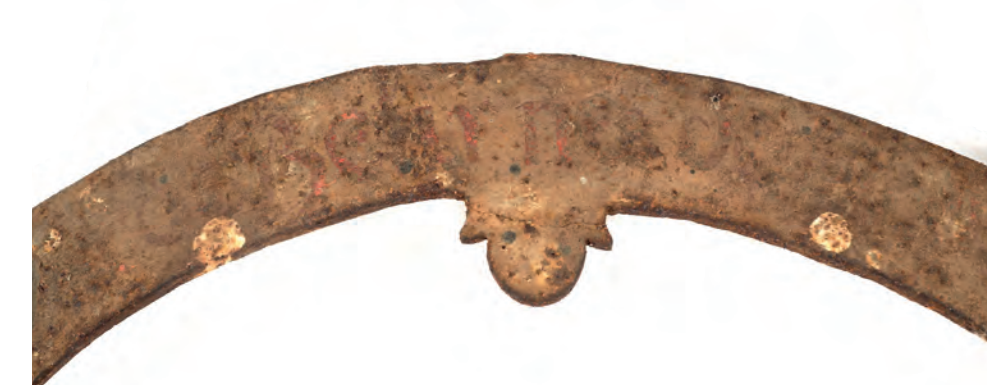
Side A detail before restoration

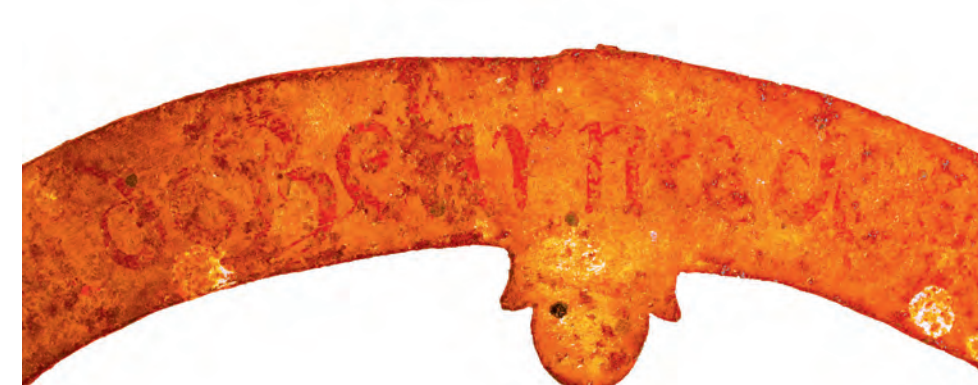
Side A detail (da Behr neé de) before rest., photo alteration

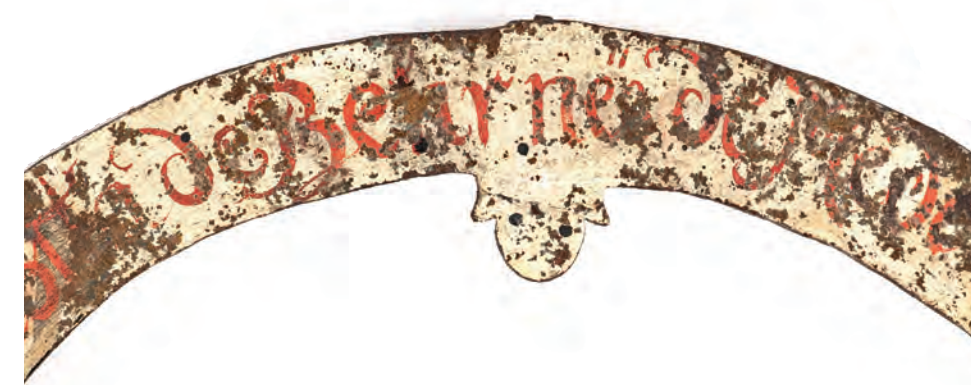
Side A detail after chemical treatment

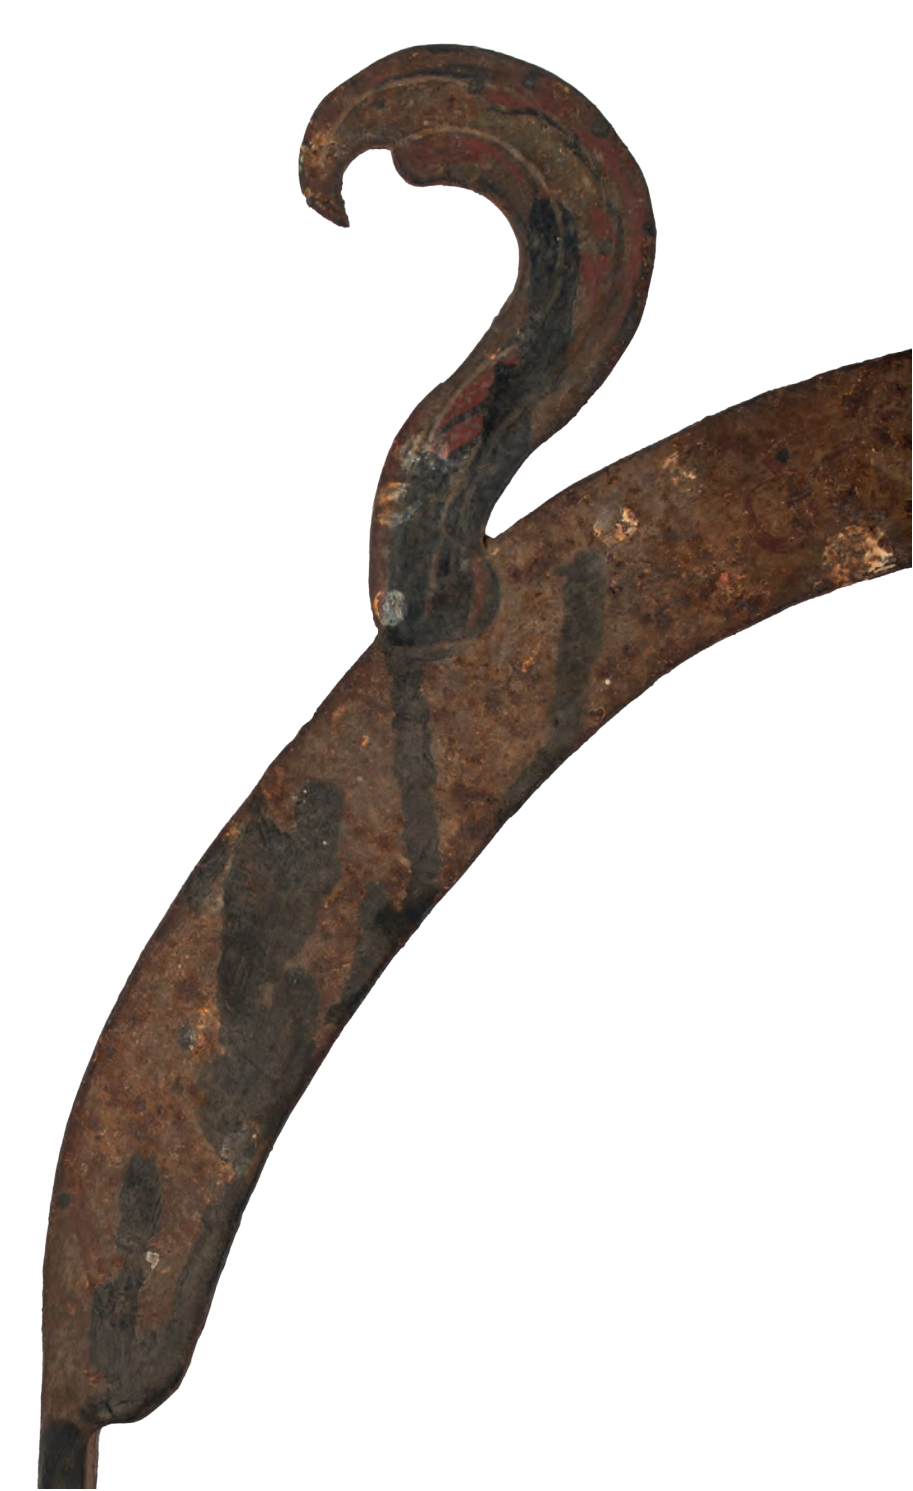
Tar run-offs before restoration

After corrosion reduction, large areas of the original paint layer were found to be well preserved and firmly adhered to the metal. Tar run-offs presented the greatest challenge. The most successful approach involved gentle heating to soften the tar, followed by careful mechanical removal. Further removal of tar deposits and treatment of remaining areas of metal corrosion are required. These will be addressed through localised application of acid compresses combined with careful mechanical cleaning. Following corrosion reduction, the metal surface will be passivated, and a protective coating will be applied.

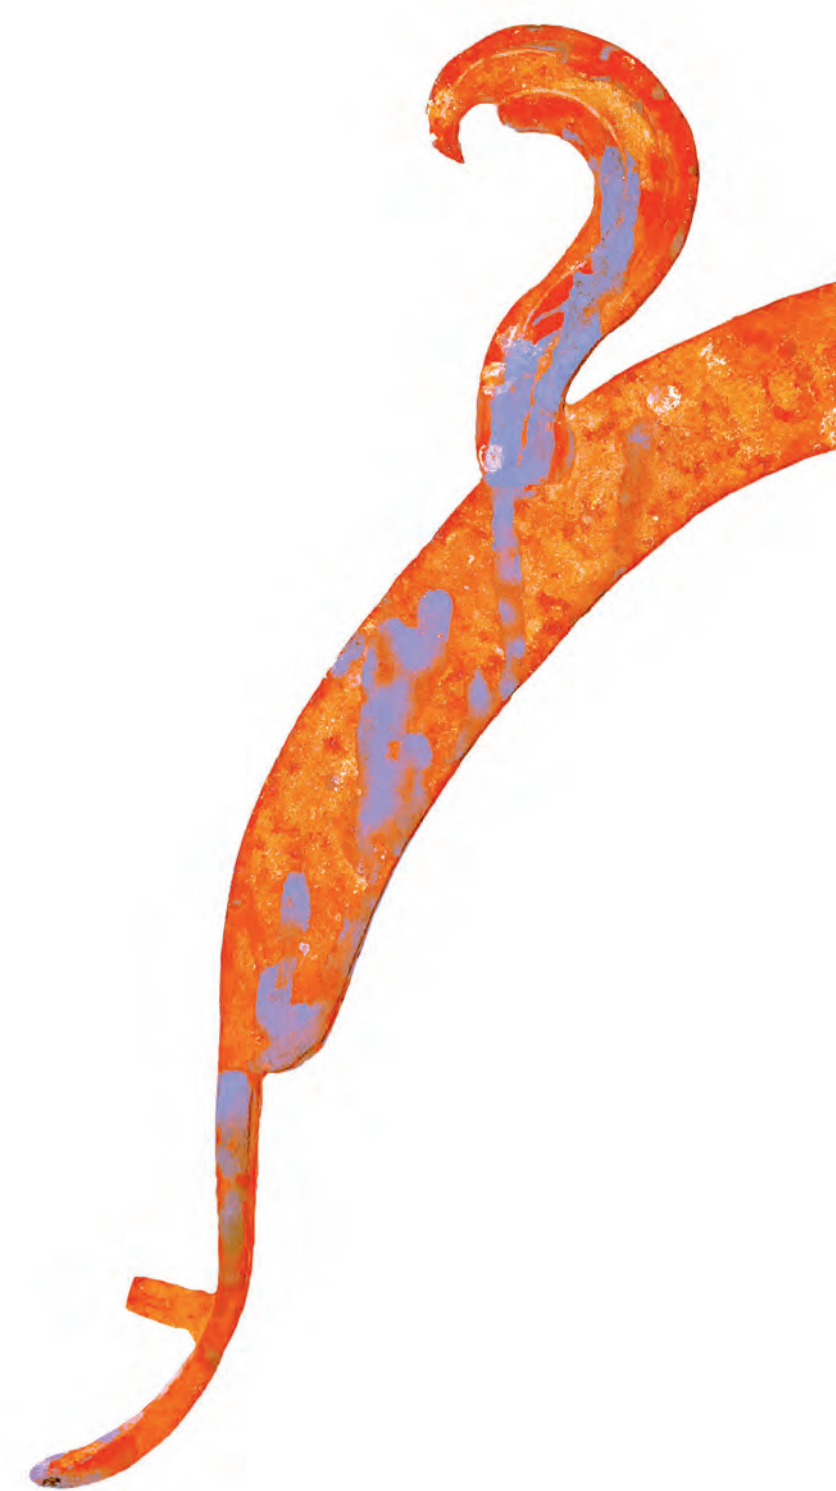
Tar run-offs before rest., photo alteration

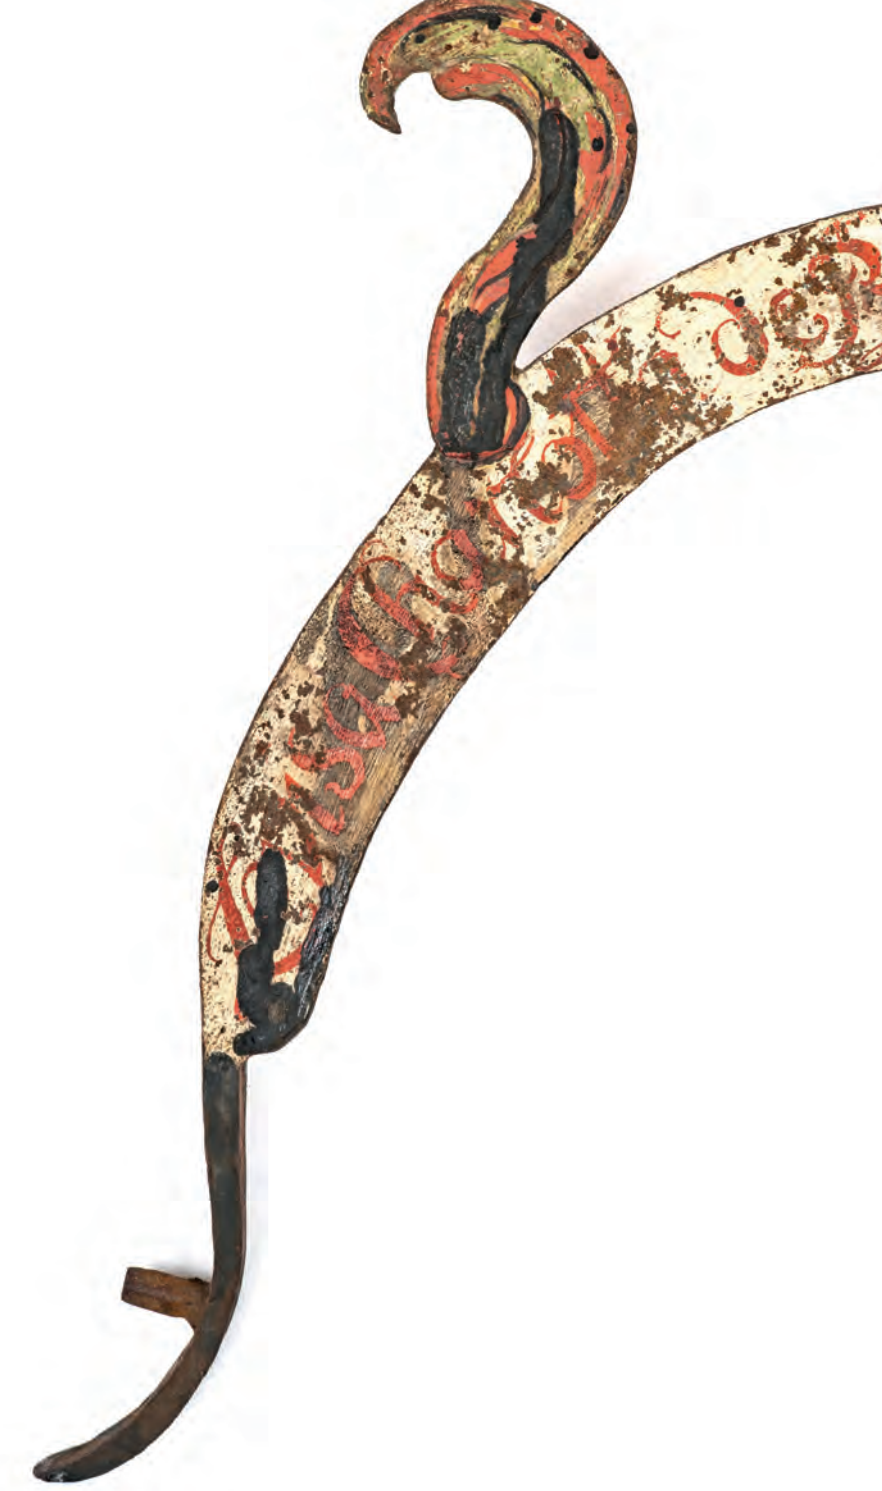
Tar run-offs after chemical and mechanical treatment

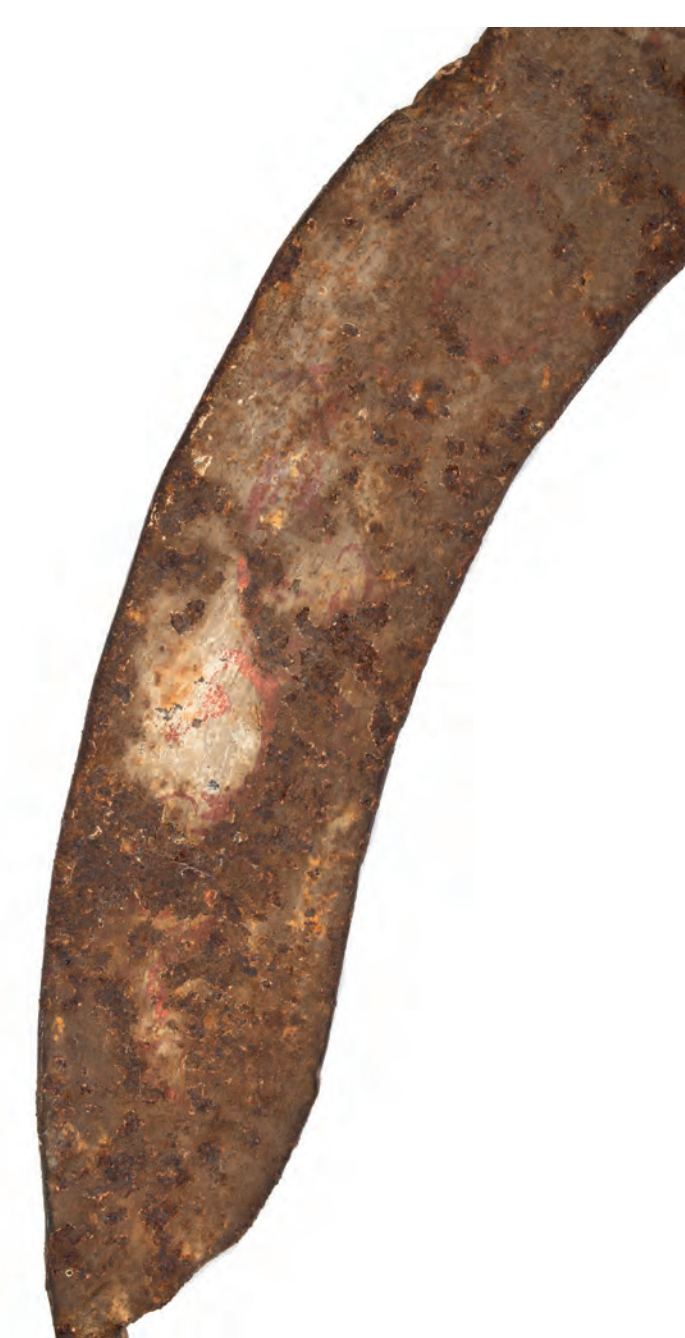
Side B acanthus leaf decoration before restoration

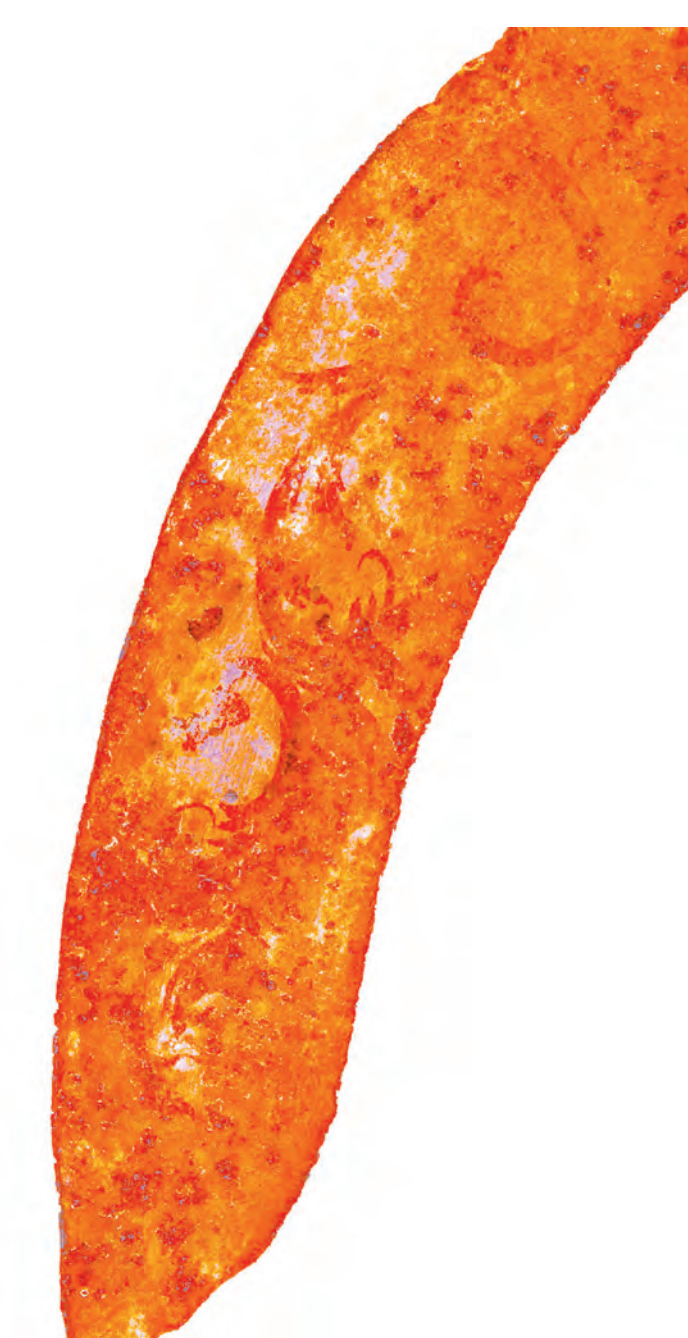
Side B acanthus leaf decoration before rest., photo alteration

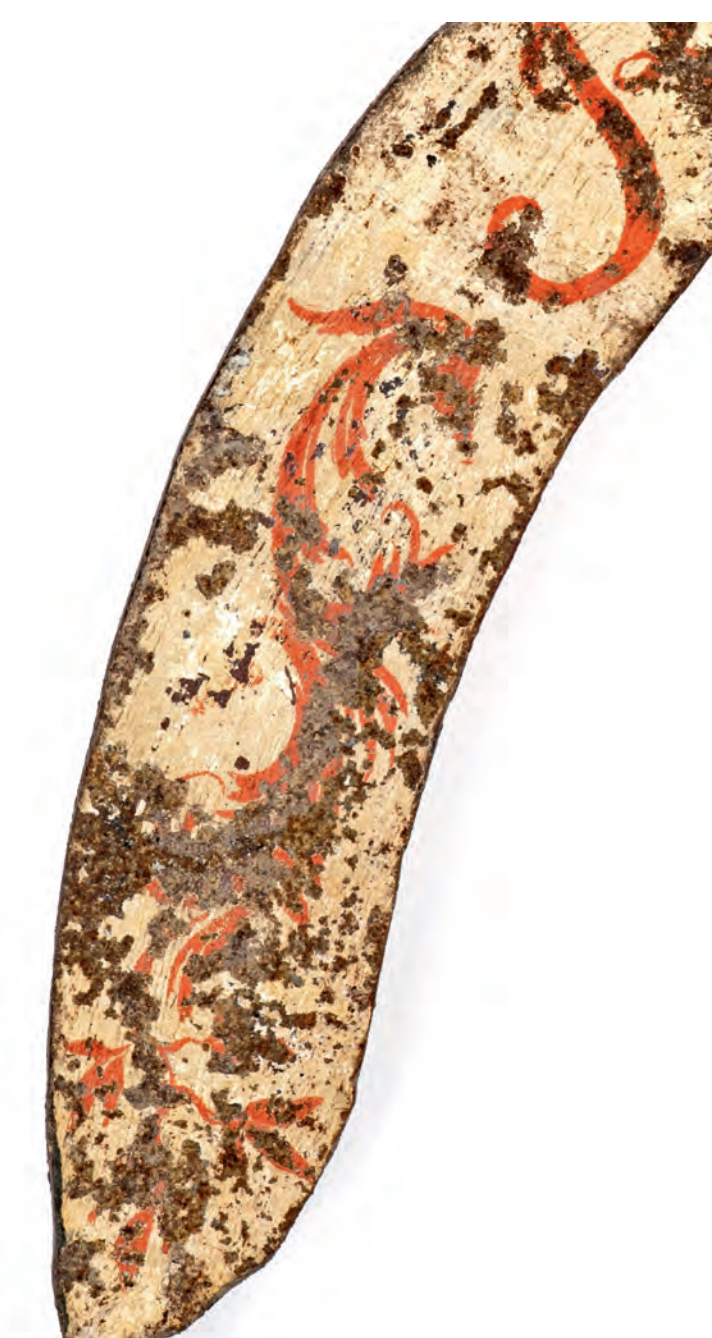
Side B acanthus leaf decoration after chemical treatment

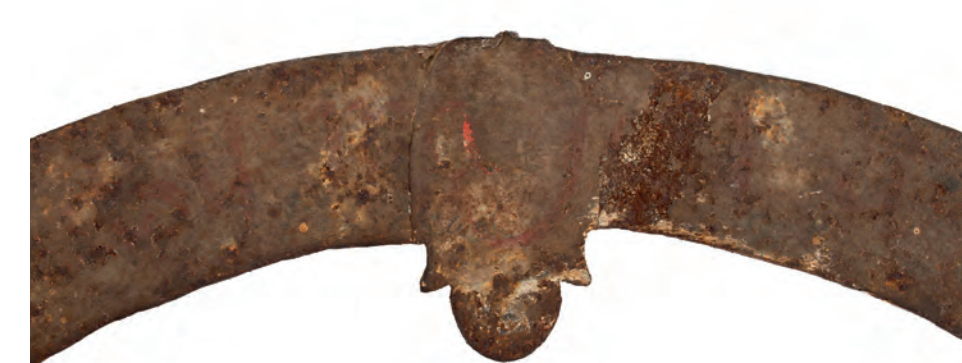
Side B detail before restoration

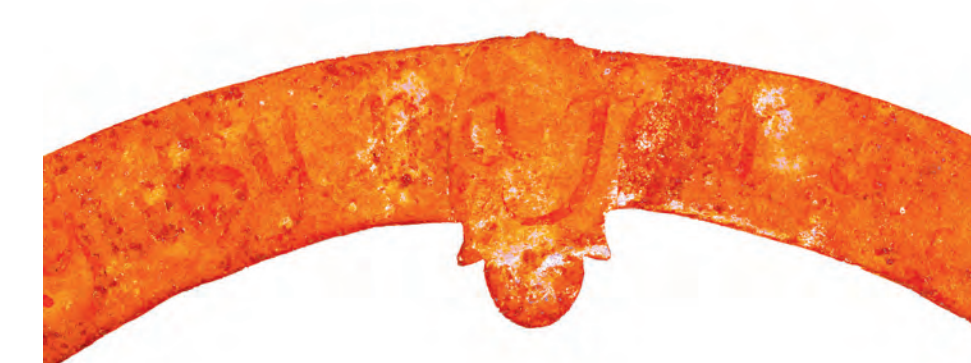
Side B detail before rest., photo alteration

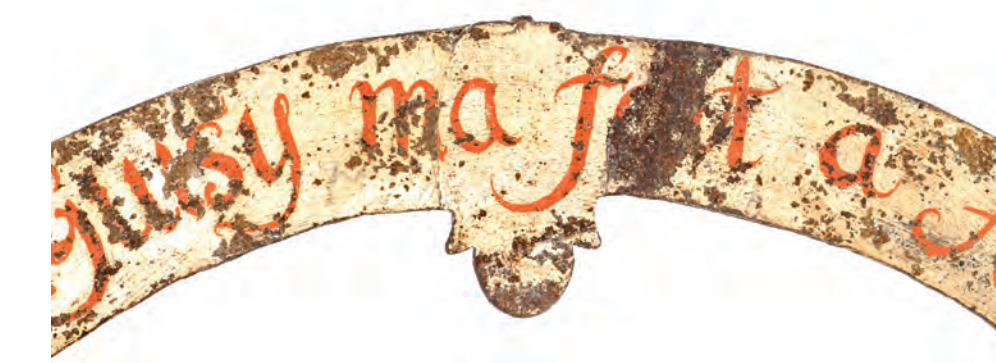
Side B detail after chemical treatment (Guisy ma fait 'a)
