This crucifix is listed as national heritage (Certificate 9348). Author and maker are unknown (maker could possibly come from settlement called Karalauči). Crucifix was initially made for Stende Lutheran Church altar retable in Talsi region. Crucifix was later acquired by Rundāle Castle Museum where it was placed until 2000 when it was moved to Talsi Evangelical Lutheran Church.

Figure of the Christ possibly dates back to the 17th century, but the cross is much younger. Figure of the Christ is made of the linden tree. Cross is made of painted pine. Dimensions of the cross: height 247cm, width 165cm, width of details 15cm, depth of details 3.5cm. Horizontal beam of the cross is sunk into vertical 17cm from the top. Figure: length from toes to fingertips 230cm, arm span 134cm, depth at the height of crown of thorns 29cm.

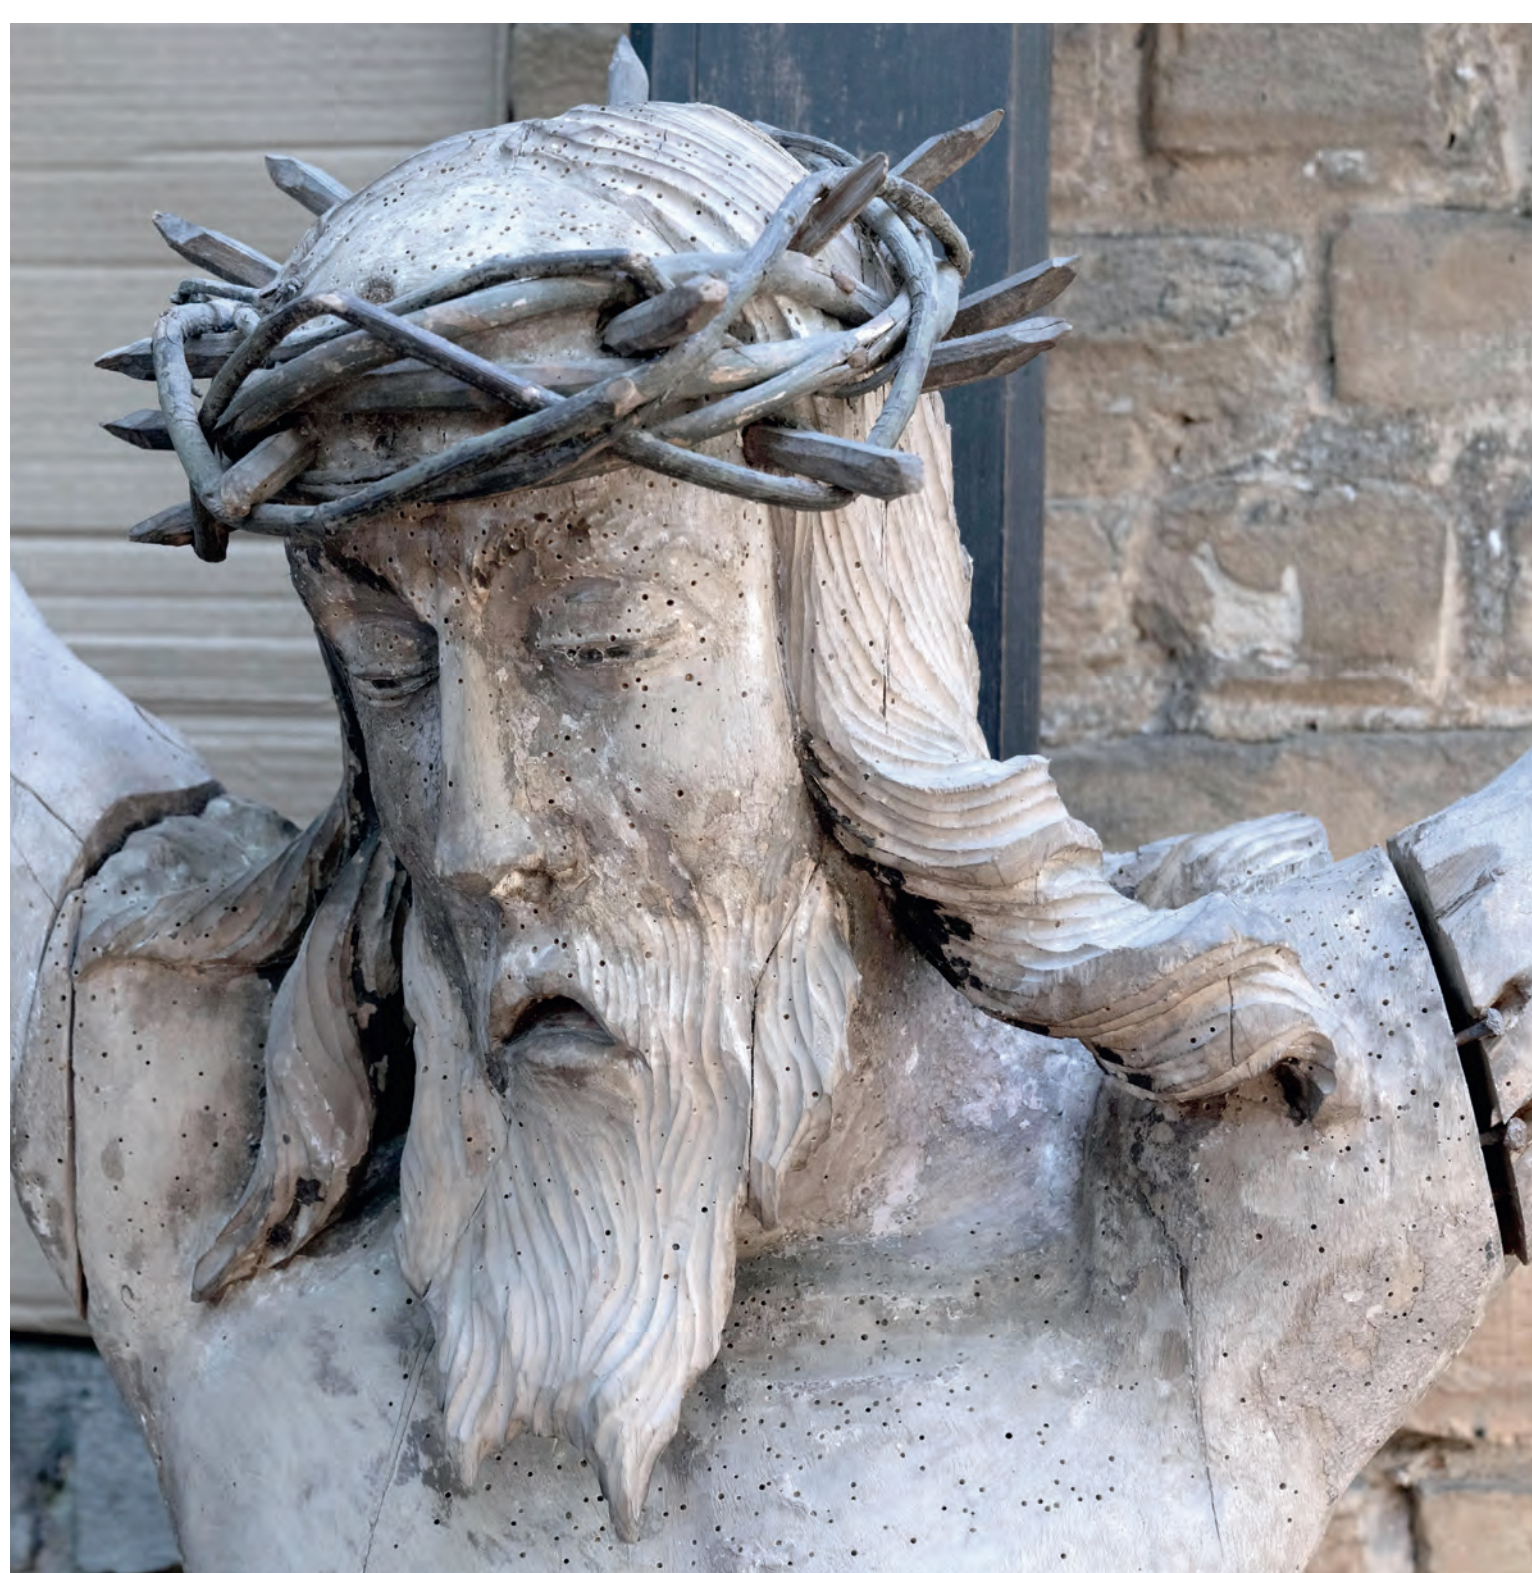
Head of figure before restoration
Photo: Aigars Pilenieks

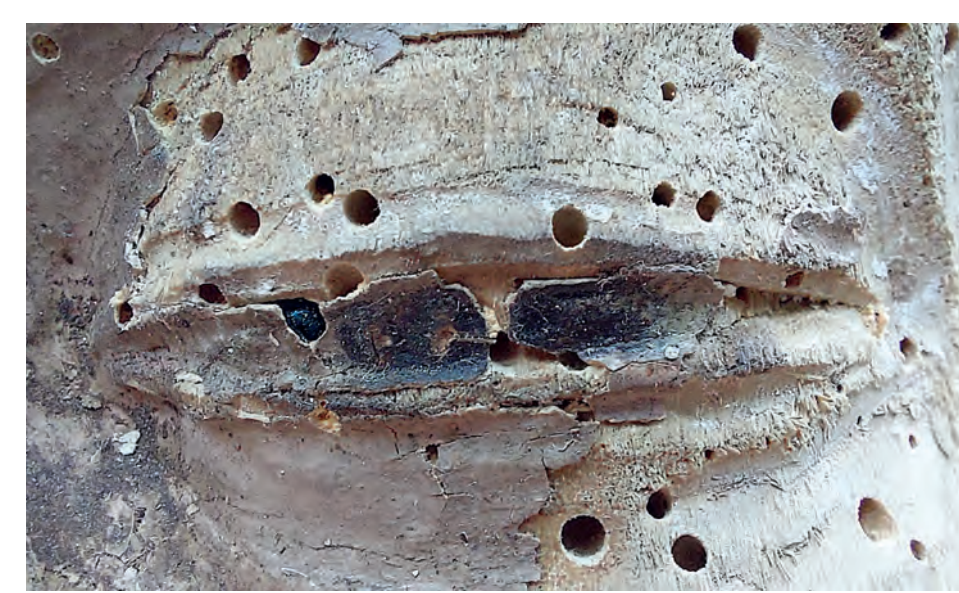
Eye area, loss of colouring, damage caused by wood beetles
Photo: Aigars Pilenieks

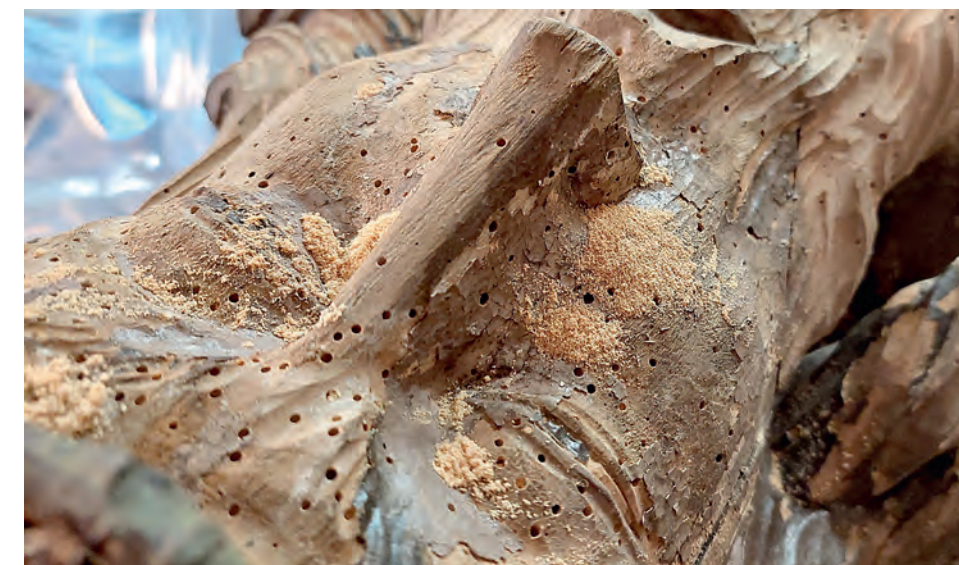
Head of figure, damage caused by wood beetles
Photo: Aigars Pilenieks

Pre-restoration examination of the art piece in the church revealed wide damage caused by woodboring beetles. There was also the visual evidence of continued damage – small pyramid-shaped piles of wood flour had formed in various parts of the figure, especially the head area and feet that had been partially lost. Several species of woodboring beetles were found: *common furniture beetle Anobium punctat* and *beetle Korynetes caeruleus*. Woodboring beetles were extremely lively, they constantly moved up and down the surface of the figure in plain sight.

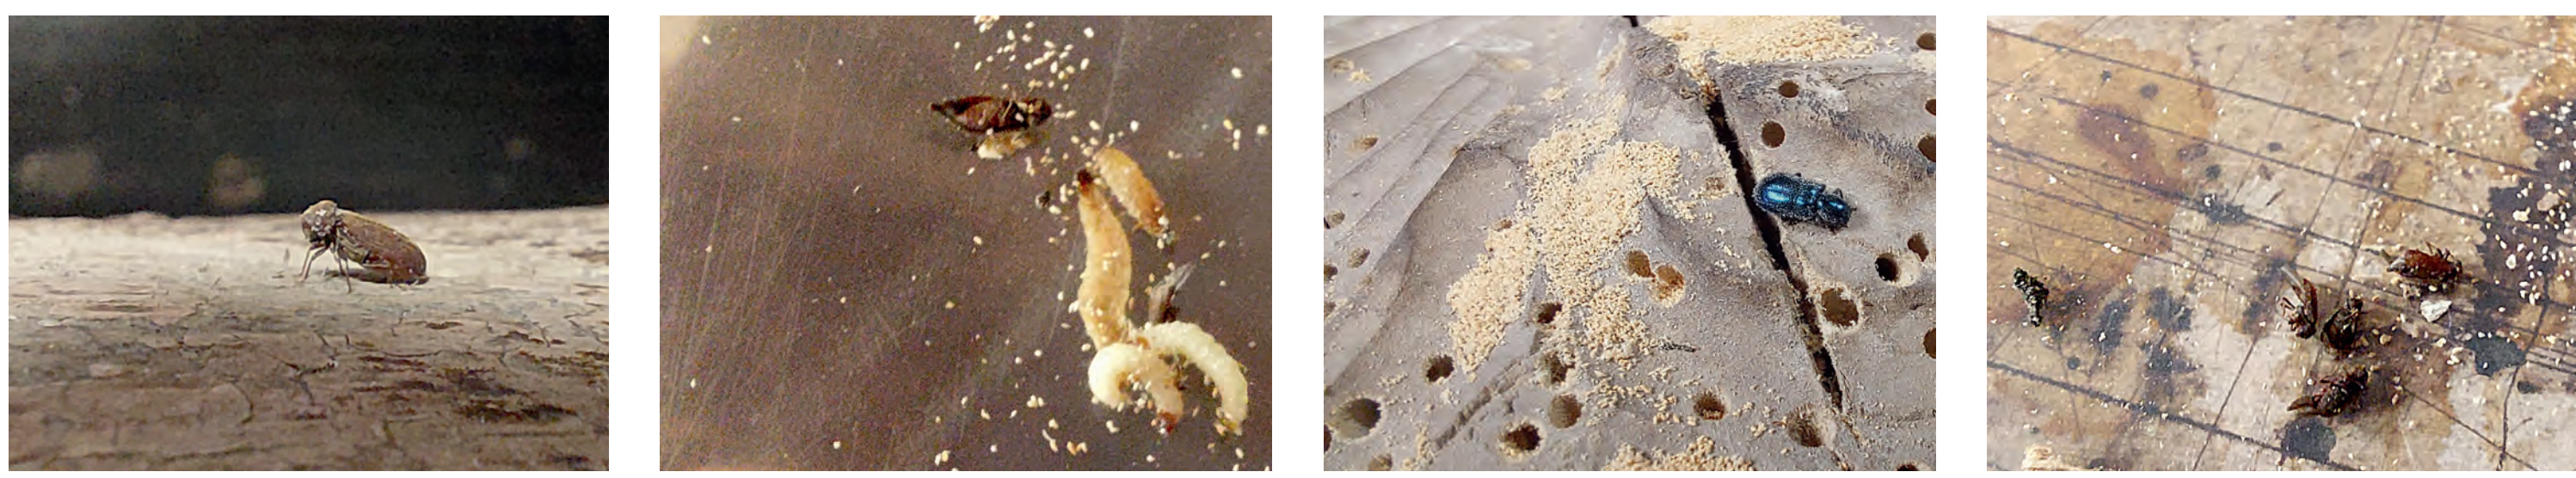
Wood beetles at different stages of development on crucifix
Photo: Aigars Pilenieks

Destruction of wood beetles
Photo: Aigars Pilenieks

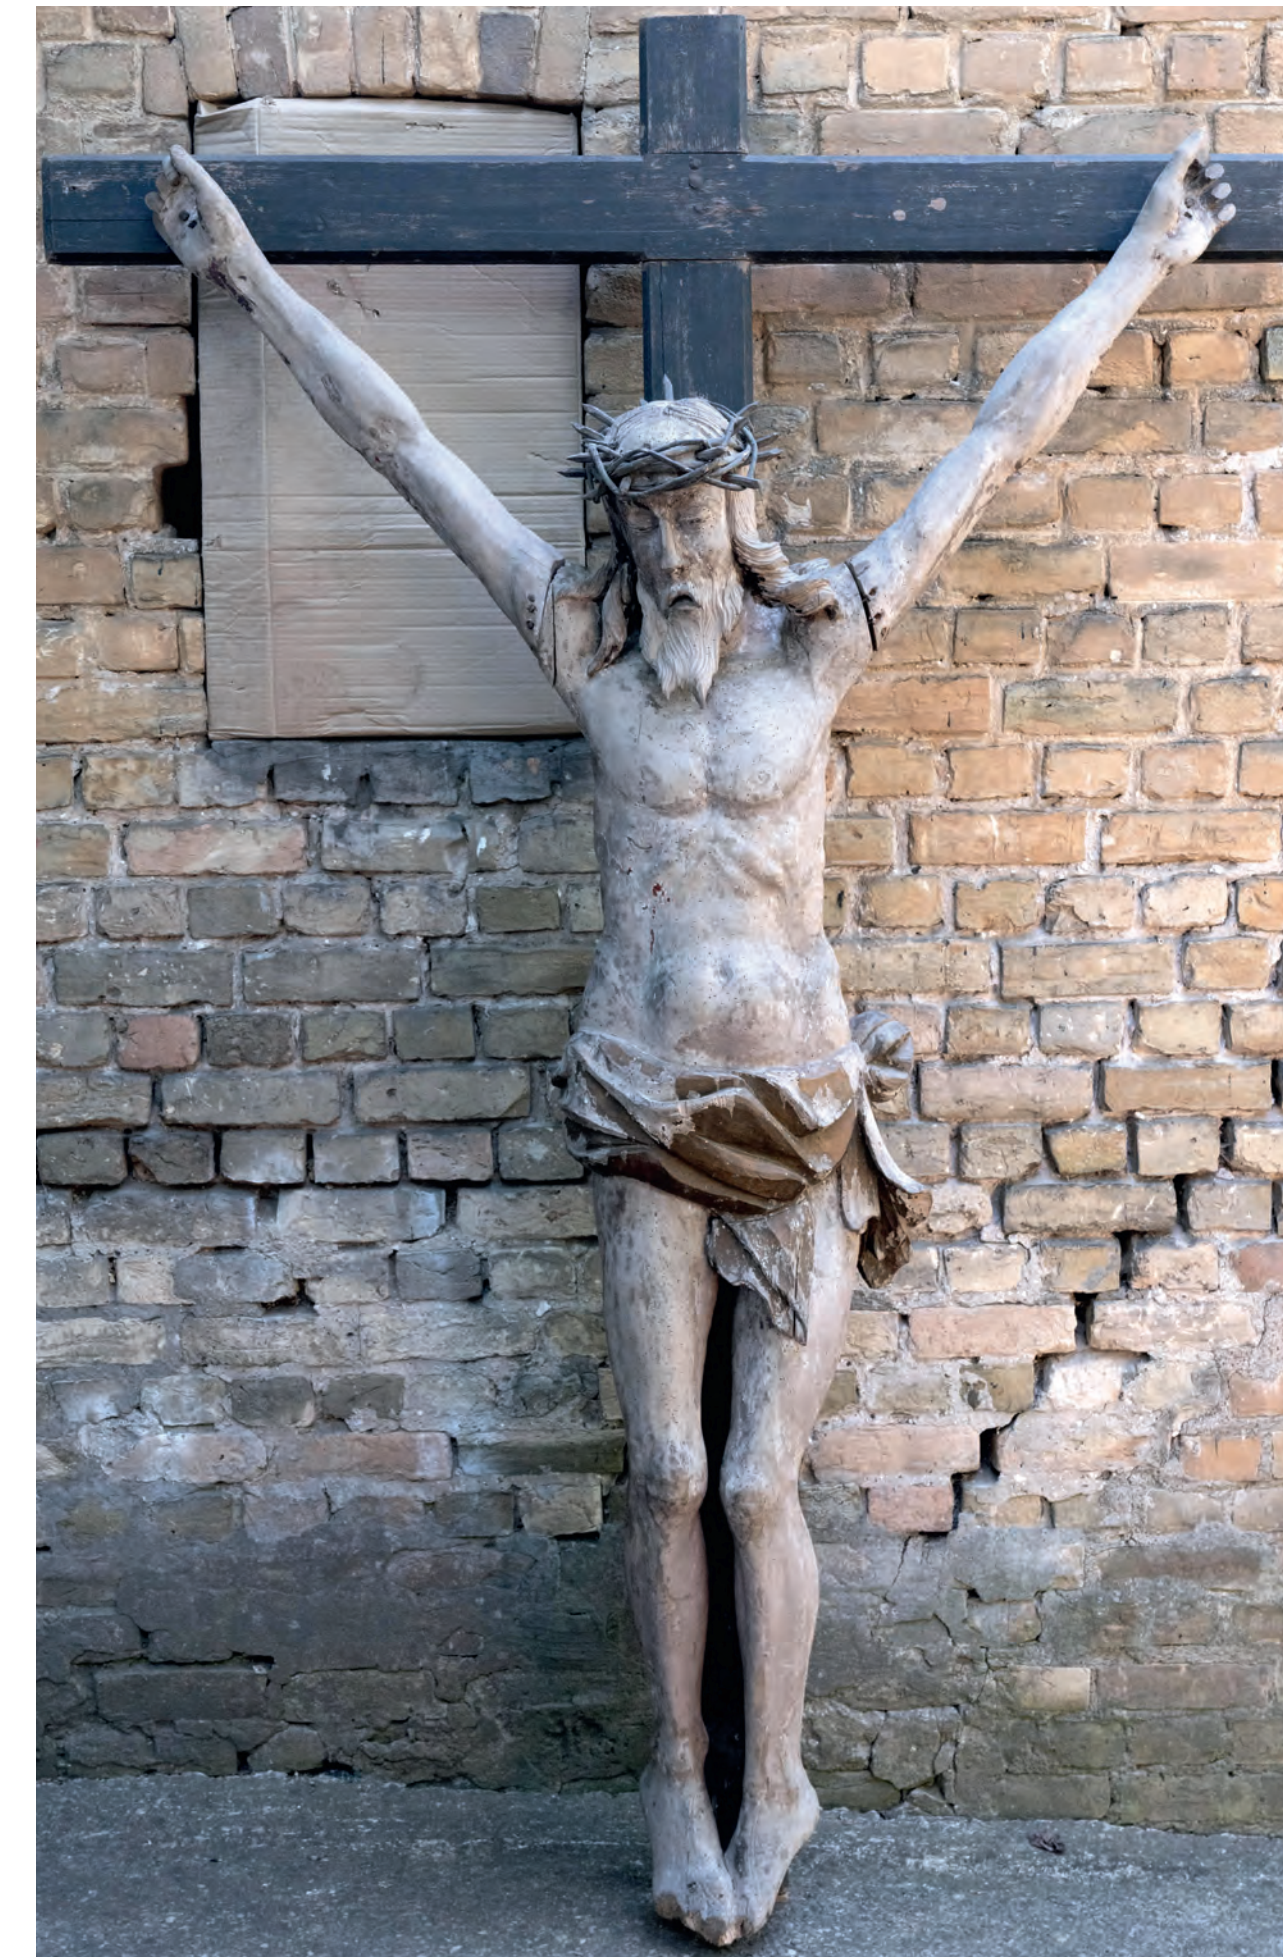
Crucifix was covered in thick layer of dirt, which suggests that it might have spent some time lying outside.

Both hands of the Christ were missing some fingers. Crown of thorns had lost several thorns. Figure of the Christ had lots of cracks that start from joints between various elements. Cracks on the side of the figure went down from shoulders to back of the legs, beneath the loincloth. Hands near the shoulders were attached with enormous amount of nails – a way bigger damage due to loss of wood that results from banging of the nails. Additional nails in the arm joints had not yielded desired results – joints were loose and there were visible gaps.

Crucifix prior to restoration
Photo: Aigars Pilenieks

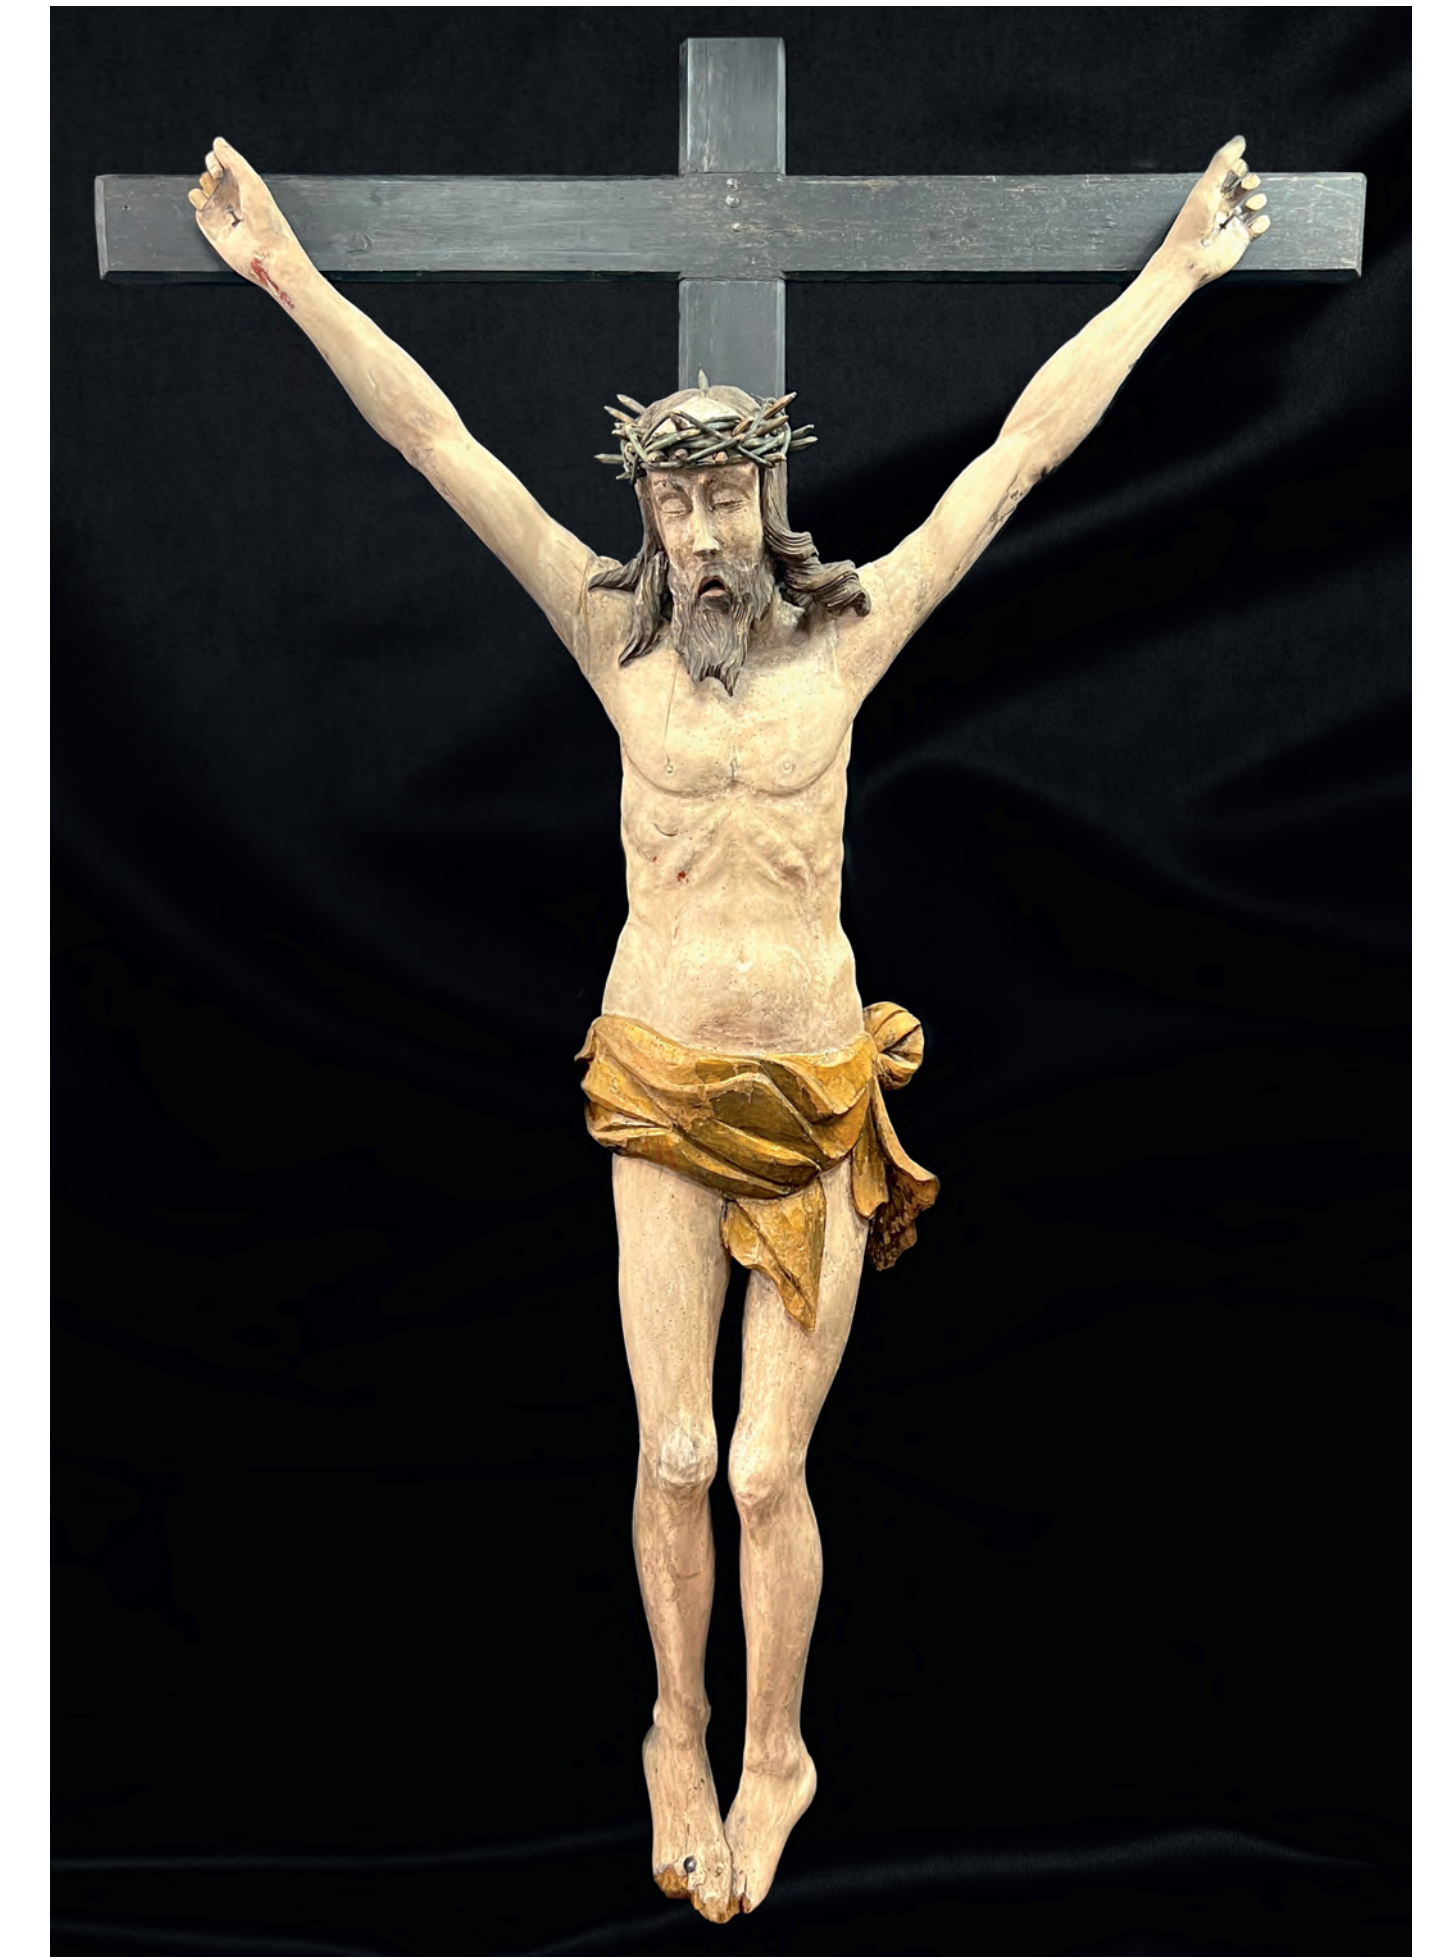
Crucifix after restoration
Photo: Mārtiņš Ziders

Structurally the wooden figure had become very weak, especially around feet. Small wood losses were visible all over the body of the Christ. There were also dents and scratches. The beams of the crucifix's cross were attached loosely, no longer serving the purpose. Cross had suffered from minor wood losses. Nails in the palms and through the feet that connected the figure to the cross, and the steel line in the back of the figure were damaged by corrosion. The first stage of crucifix reconstruction involved disassembly of the parts (hands). This allowed to place them into customised borer extermination container. Treatment with poison had to be repeated twice upon close monitoring of beetle activity. After treatment figure was cleaned, colour was fixed and toned. Places where wood was lost were filled back up. Toes and fingers were not restored because it was impossible to establish their shape. After mounting of the arms, wood inlays were toned to right shade and figure was attached back to the cross.

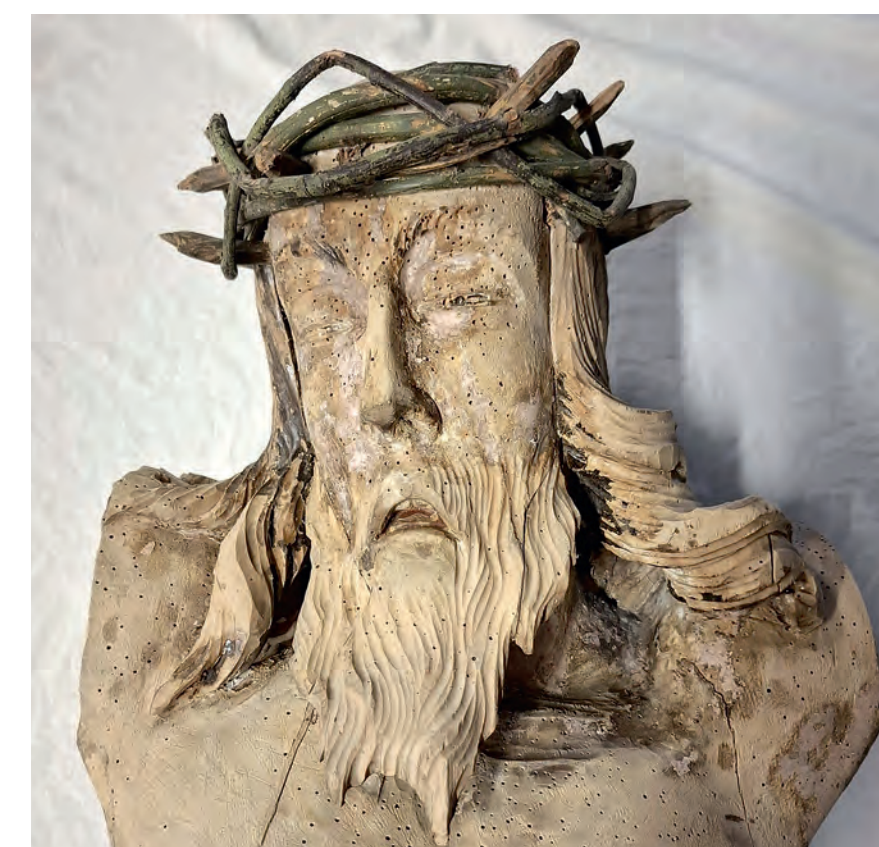
Head of figure before restoration
Photo: Sarmīte Balode
