**LĪGA ŠĻAKOTA**, Mg. art  
LMA doctoral studies, 3rd year  
Kalpaka bulvāris 13, Rīga  
liiga.slakota@gmail.com

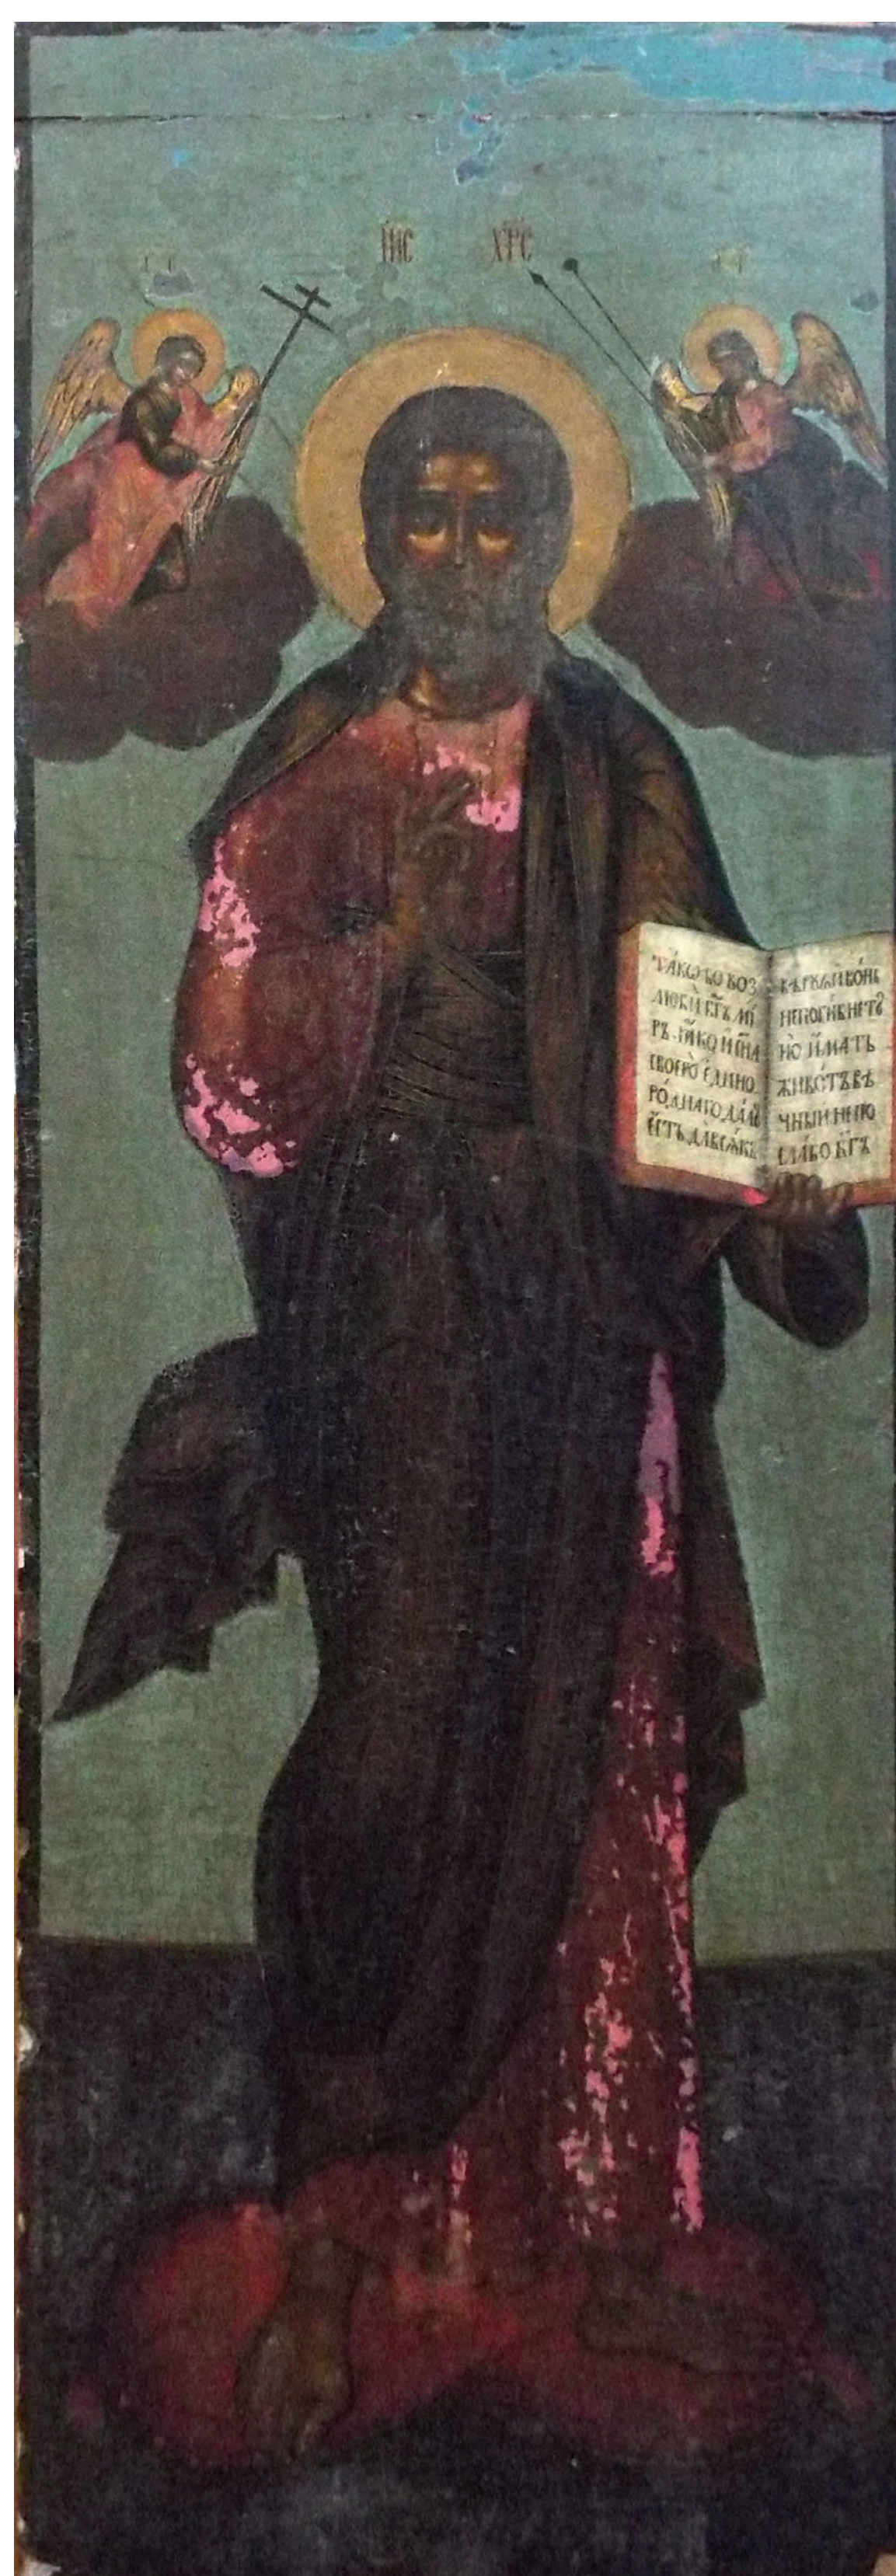
1.

The icon, wood/tempera, size 39x116x2.5 cm, late 18th century, originally came to the church as a gift, it has changed original size and the same number of layers of overpainting similar to other icons, which is evidence and indicate an earlier adaptation for the needs of the iconostasis. A 5 cm wooden strip was deliberately added to the upper part of the icon to increase its size. The base is made of two boards with vertical fibers, while the later added lath has horizontal fibers. The original base was curved in the shape of a shield, but the strip remained straight, creating a gap and a pronounced step between the two parts. The quality of the painting was difficult to access the layer of varnish had blackened (Image 1). The background seemed inorganically fresh and did not correspond in colour to the figure, and the inscription above the shoulders and the letters in the halo were missing, which already initially indicated that the background had been overpainted. UV rays revealed absorption of the rays in the lower part of the icon, where various restoration primers had been applied during previous repairs. Micro-cross-section examination revealed that there were three layers of overpainting in the top of the icon, and two in the lower part – with intermediate layers of varnish. The oldest layer of paint was missing on the later added strip, but a layer of dark brown putty was found at the joint.
