RESTORATION OF THE ALTAR COLUMNS OF SKAISTKALNE CHURCH

LĪGA JANSONE, Mg. art. Department of Restoration,
self-employed restorer
Bauska, Latvia
info@ligajansone.com

Catalogue information: Baroque altar, end of the 17th century, unknown author, polychrome wood, gilding, altar height 14 m.

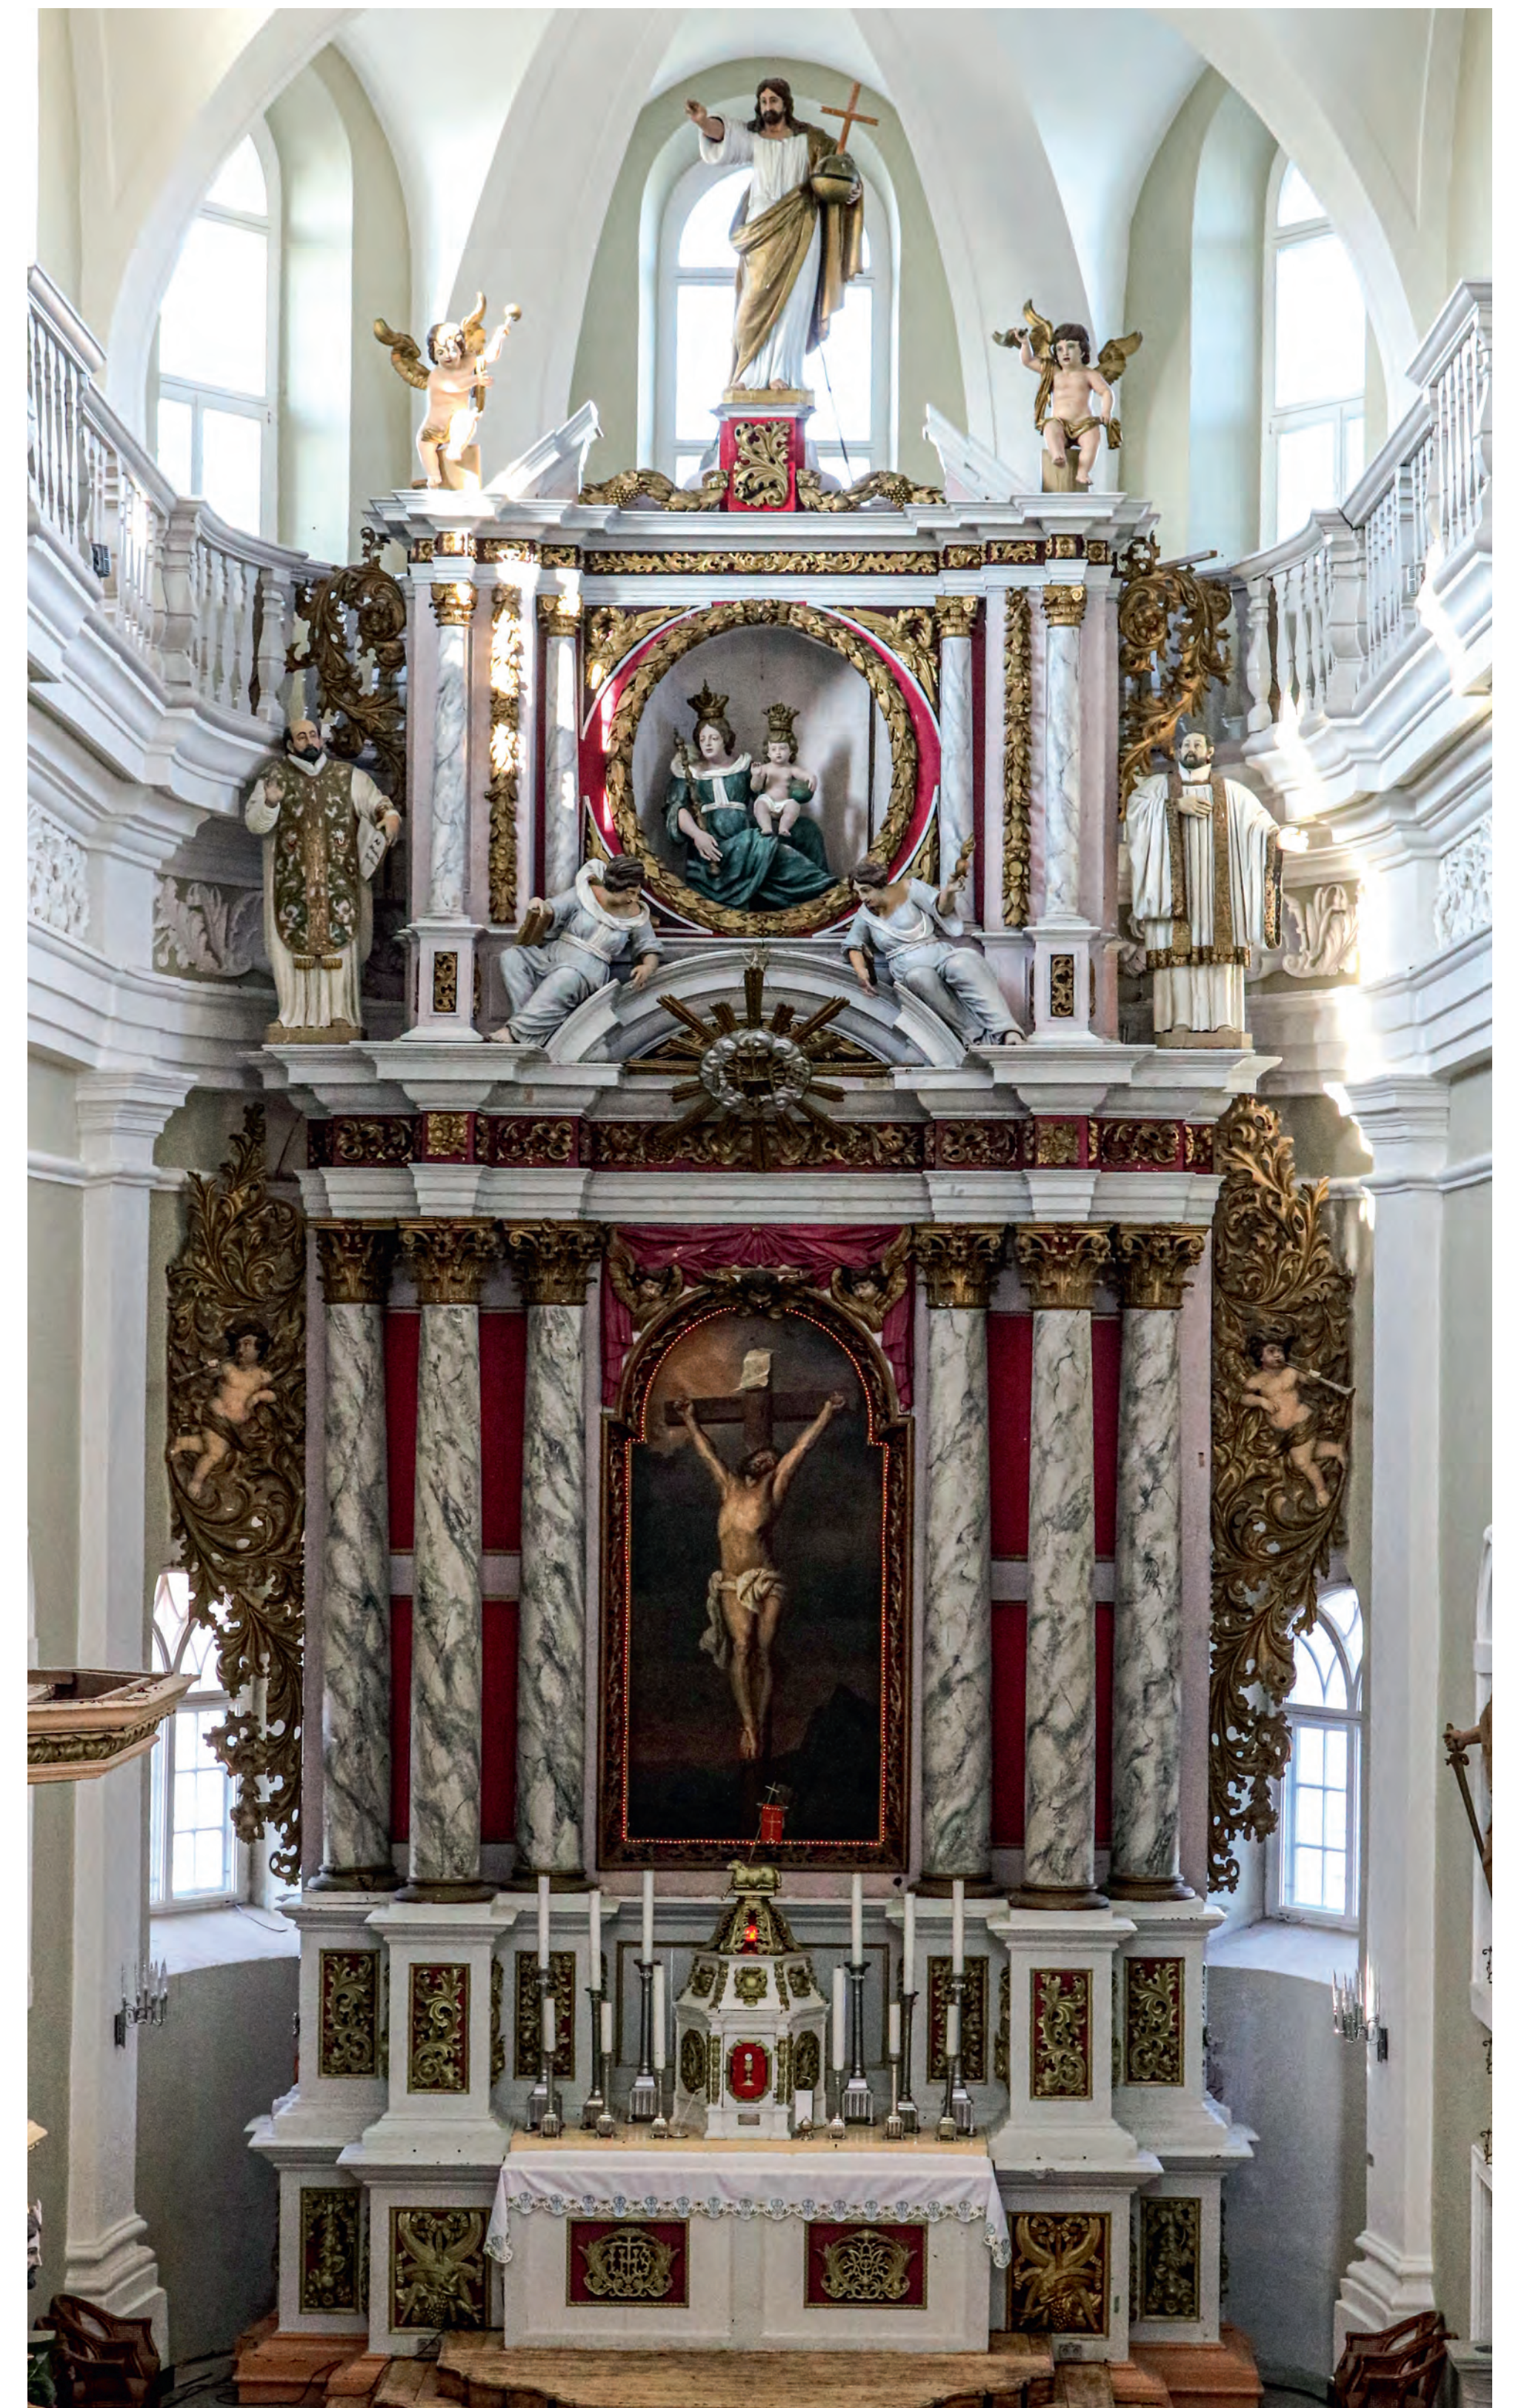
The ground layer, together with the original painting, has suffered severe damage - most likely due to unsuitable climatic conditions, which caused a loss of adhesion to the substrate and the beginning of detachment - with losses estimated at around 70–80% of the total surface. Under raking light, areas can be seen where the original ground layer has survived.

Overview of the altar of Skaistkalne Church before restoration

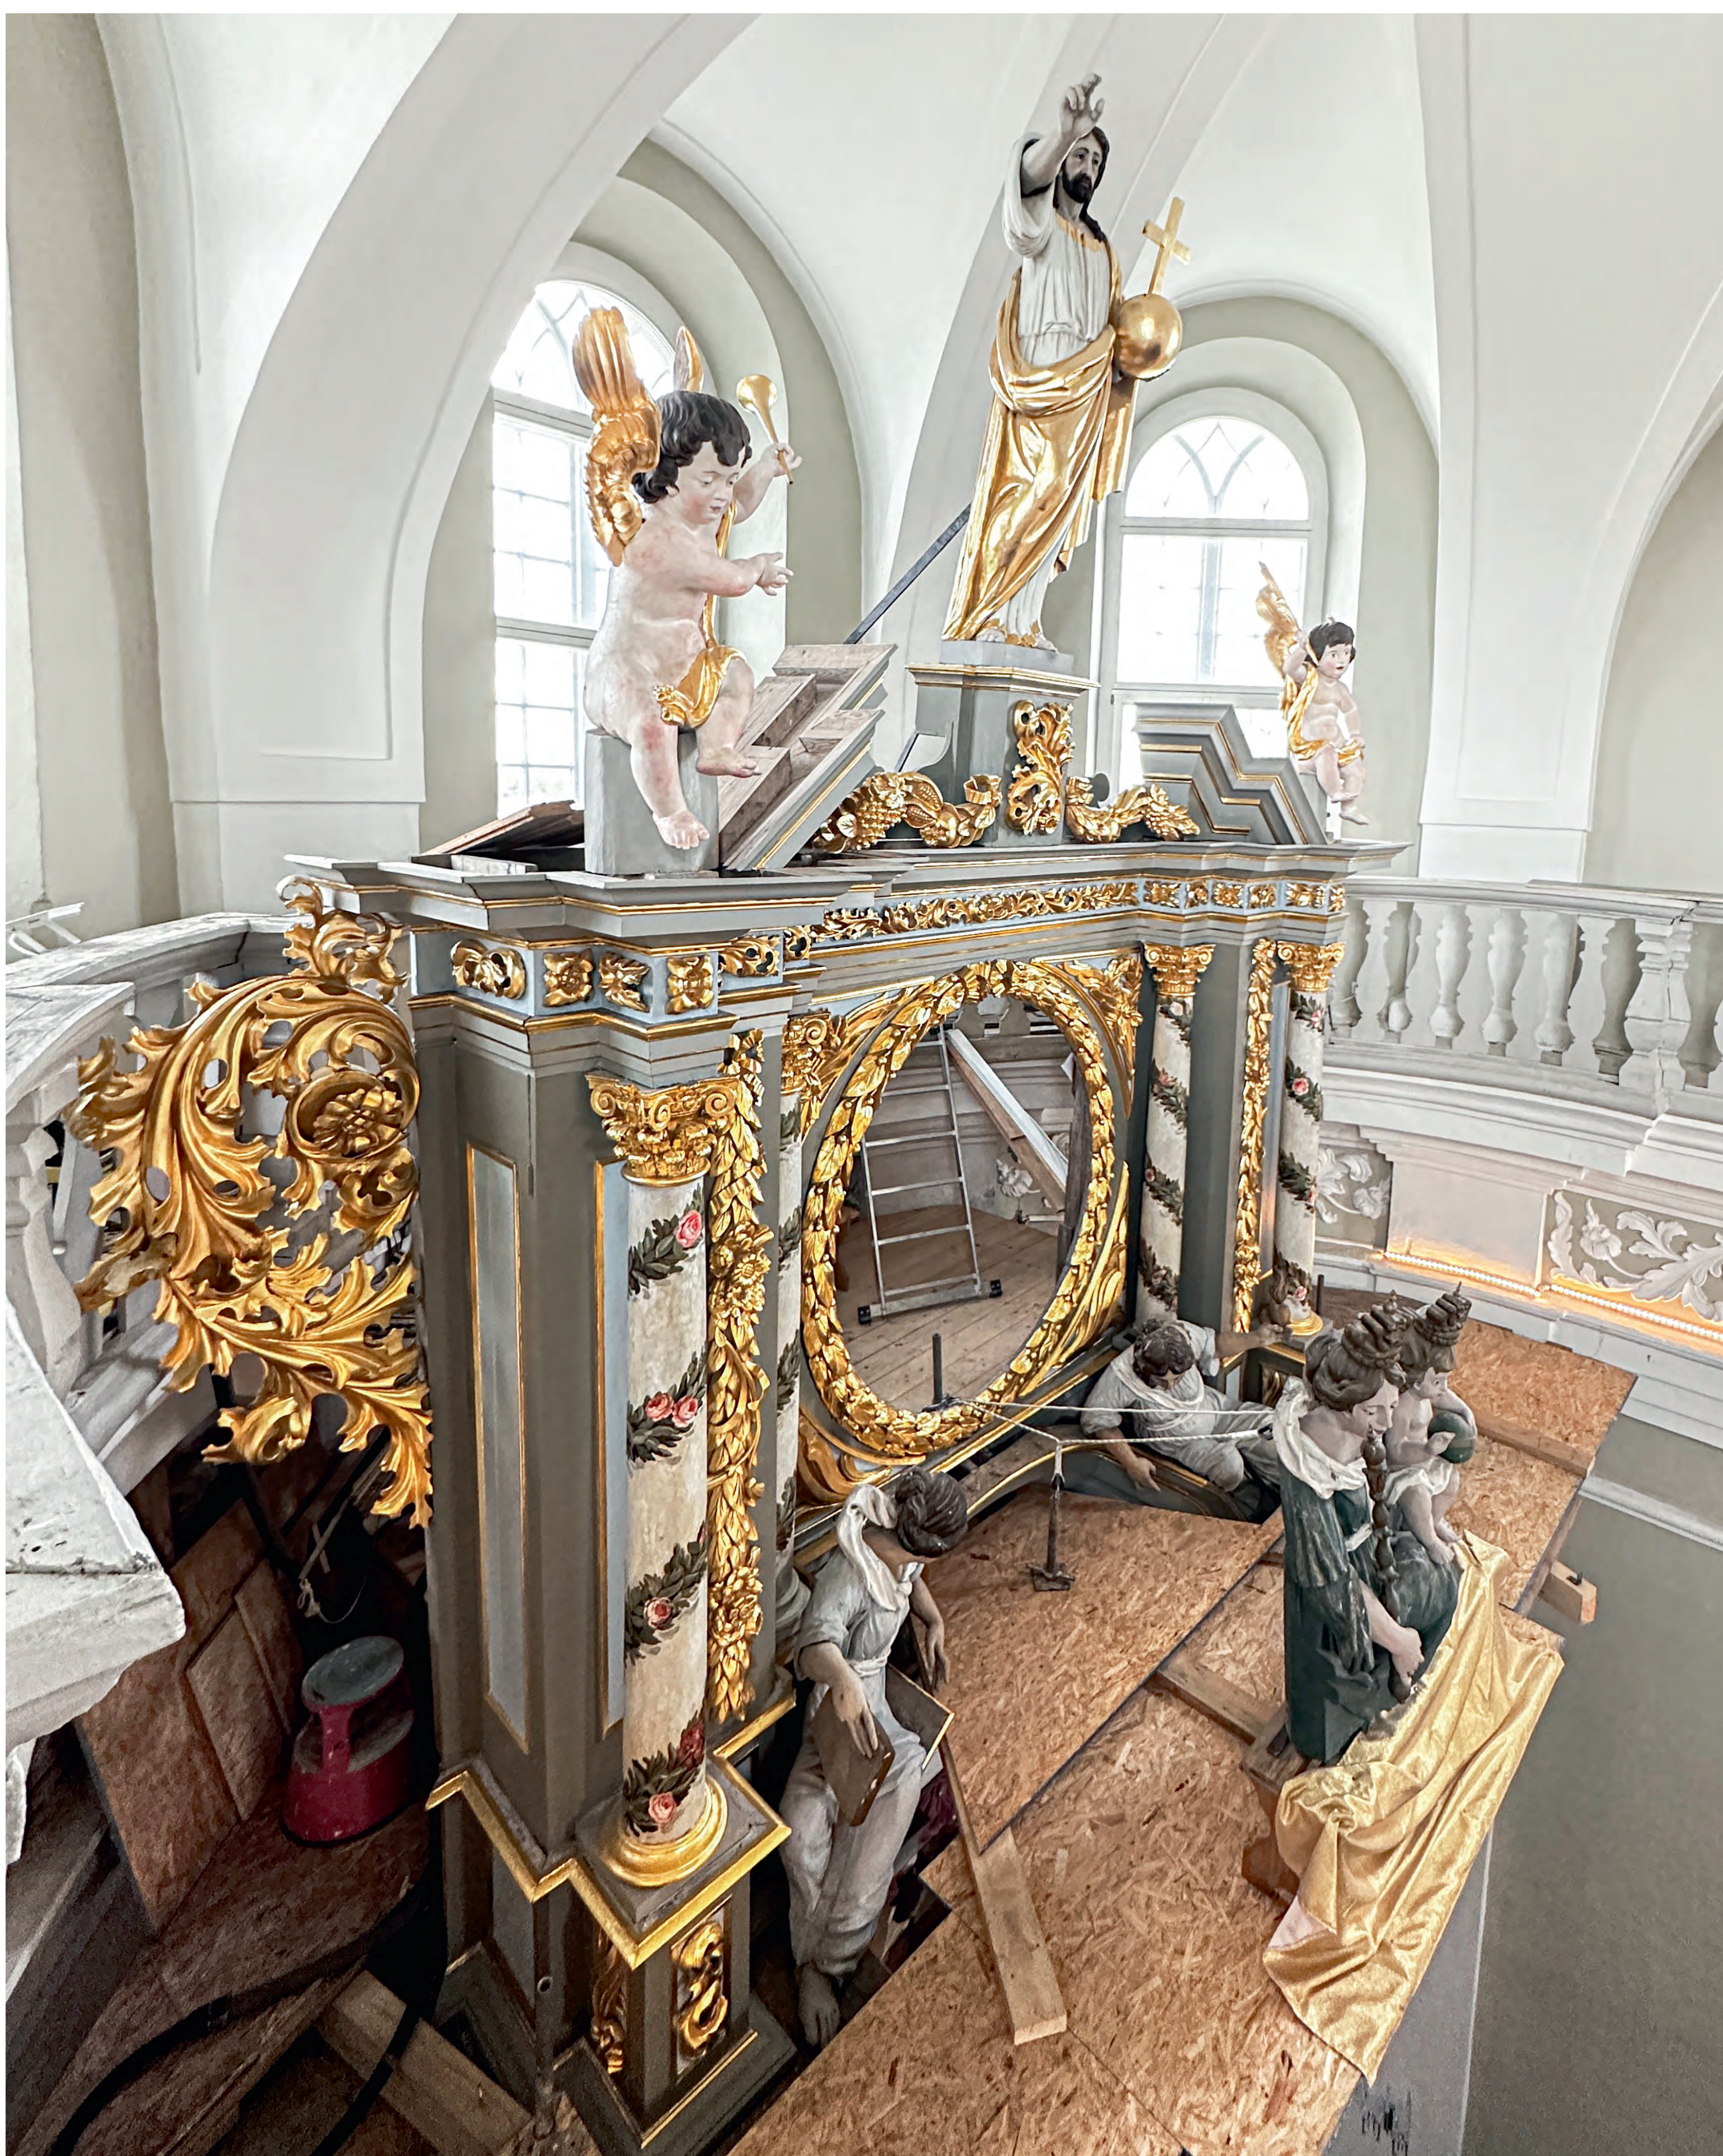
Upper part of altar after restoration

1. Removal of overpainting was performed chemically, layer by layer, using gel compresses, as well as scalpels and small cotton swabs.
2. Consolidation of the paint layers was carried out with Lascaux acrylic-based adhesive Medium for Consolidation at a concentration of 5–10%.
3. Damaged wood areas were impregnated and stabilized with a 5% solution of ethyl methacrylate copolymer Paraloid B72 in ethanol.
4. Areas of paint loss were filled with a ground composed of toned chalk and acrylic binder.
5. Loss areas were toned and reconstructed using Schmincke MUSSINI retouching paints.
6. Gilding was performed using an oil varnish (3-hour mixture) with 23.5-carat fixed gold leaf sheets measuring 8 × 8 cm.

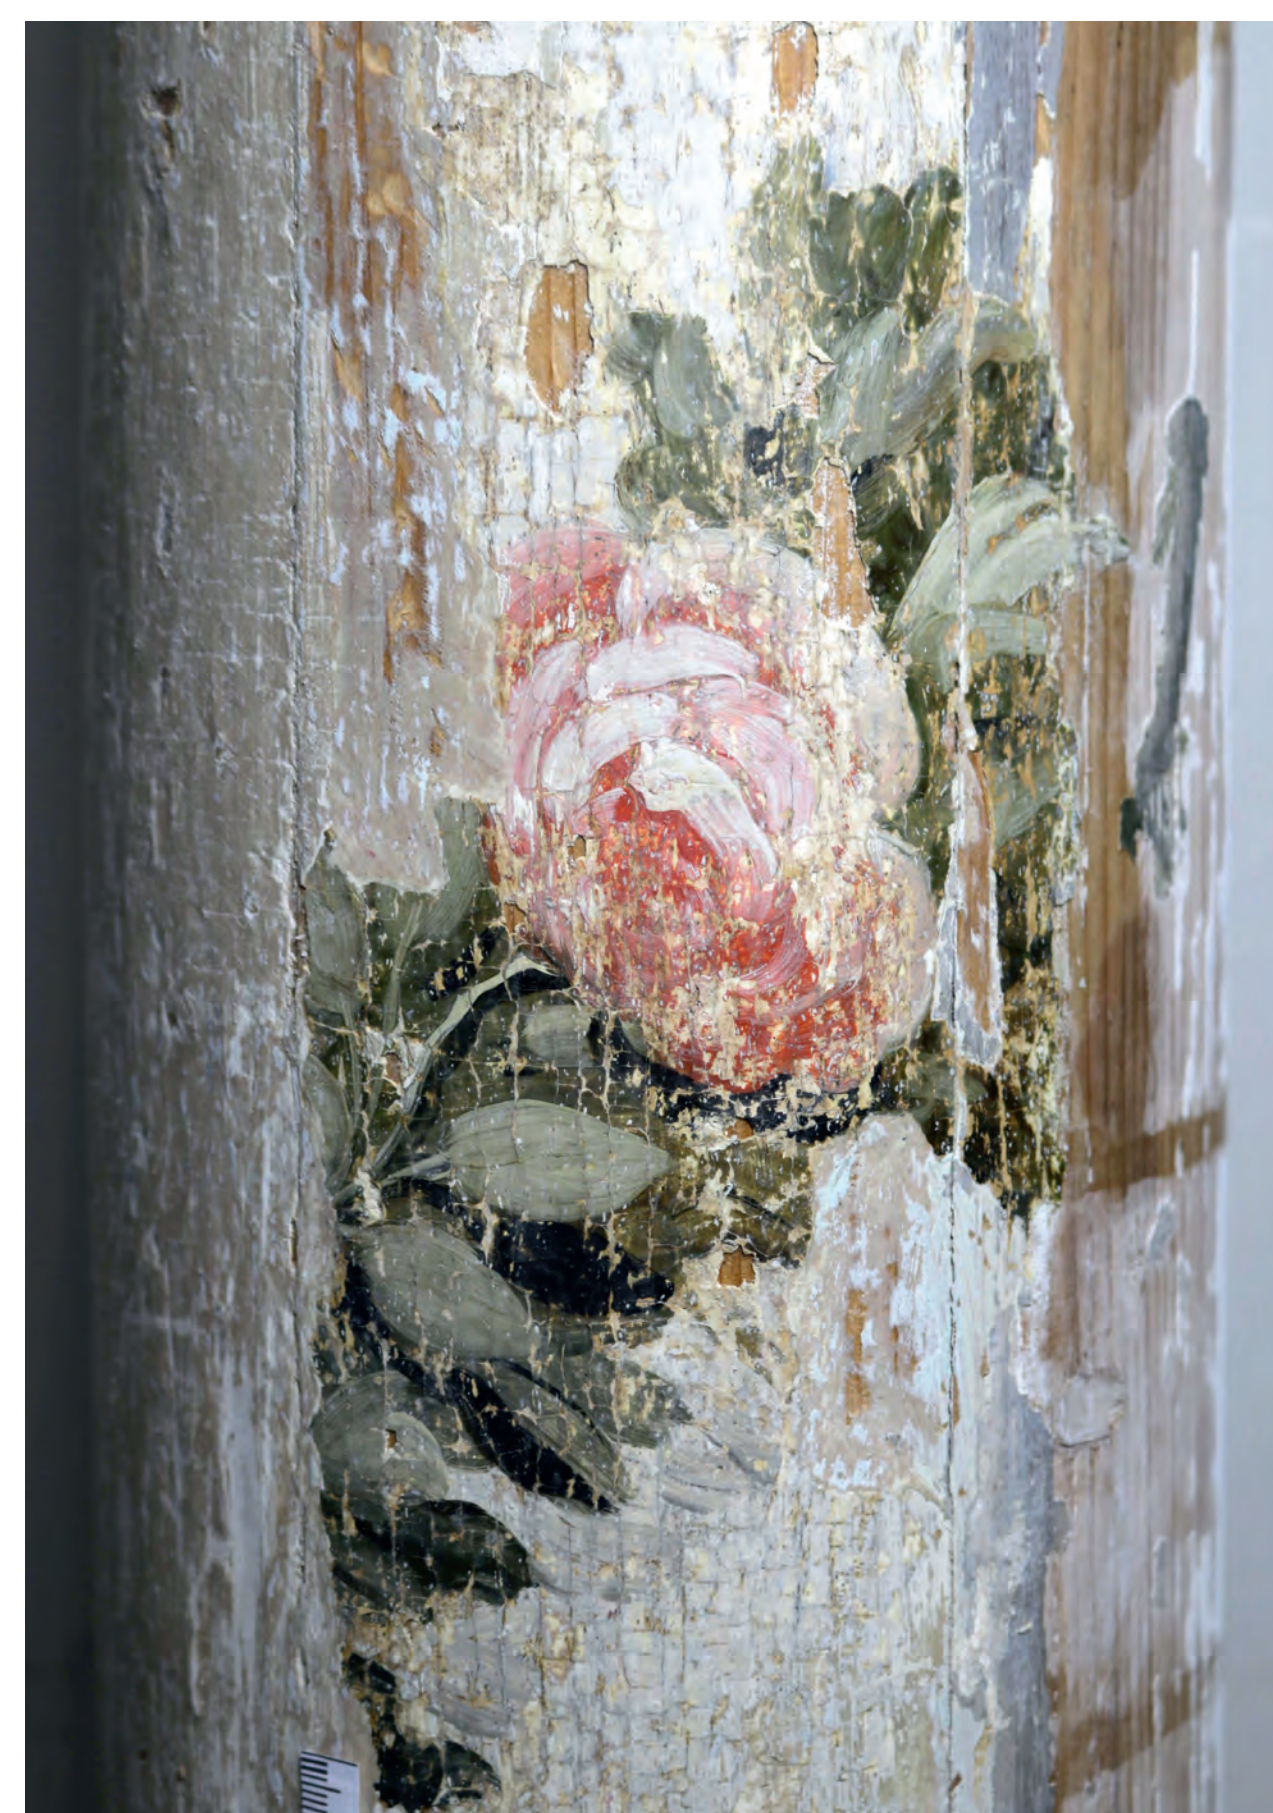
During the research of columns, it was believed that the original columns were painted to imitate red marble. During restoration, under five layers of overpainting, fragments of the original decoration were uncovered. Although poorly preserved, the composition can be identified as green leafy garlands with red flowers winding around the light grey columns.

Fragment of the painted columns after restoration

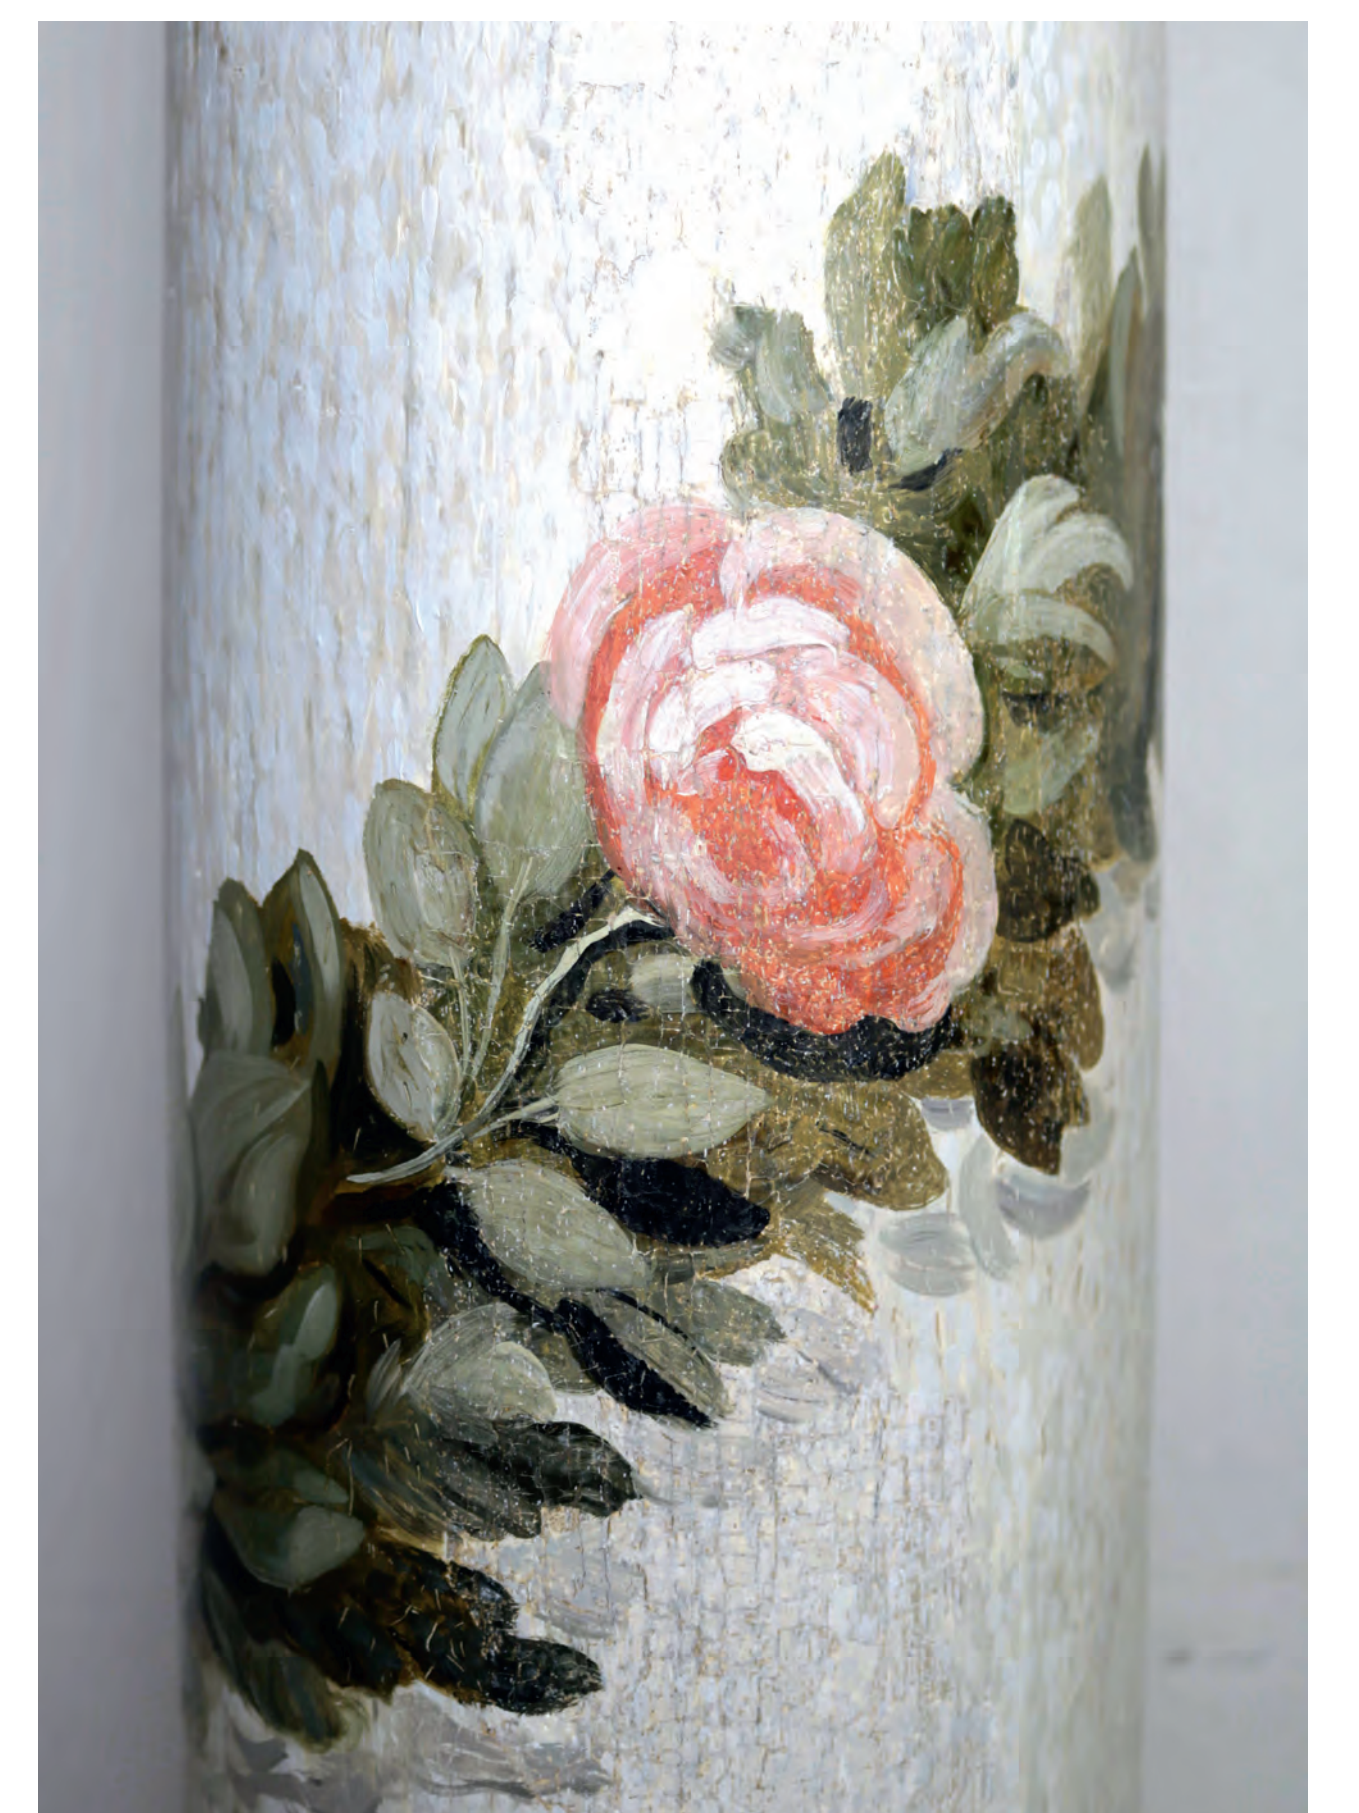
Fragment of the painted columns after overpaint removal
