CASES OF UNTYPICAL APPLICATION OF GYPSUM IN CULTURAL HERITAGE OF LATVIA

SUMMARY

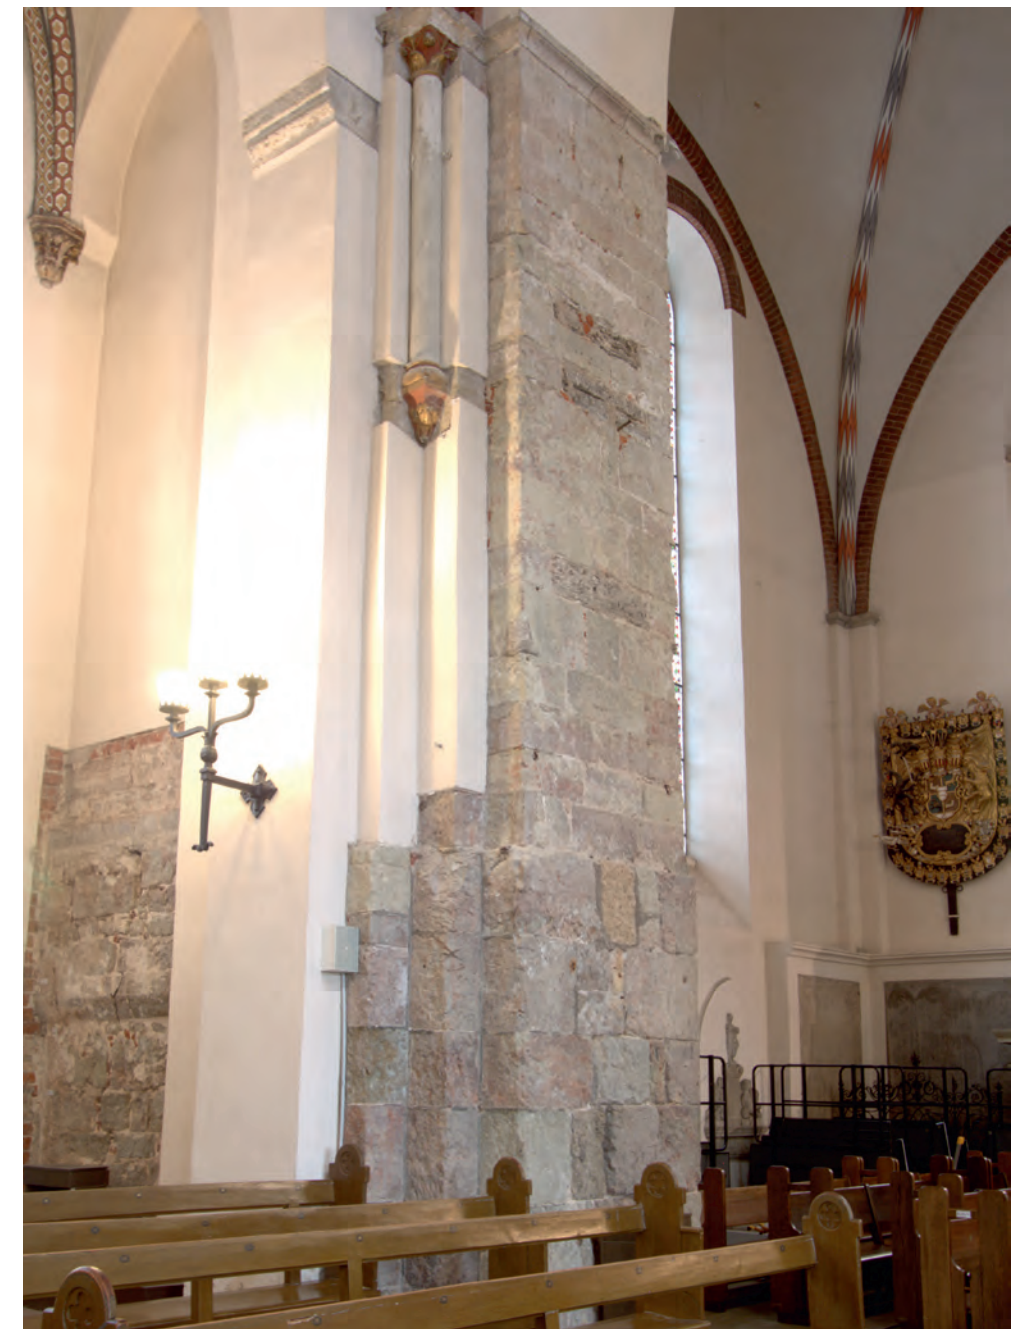
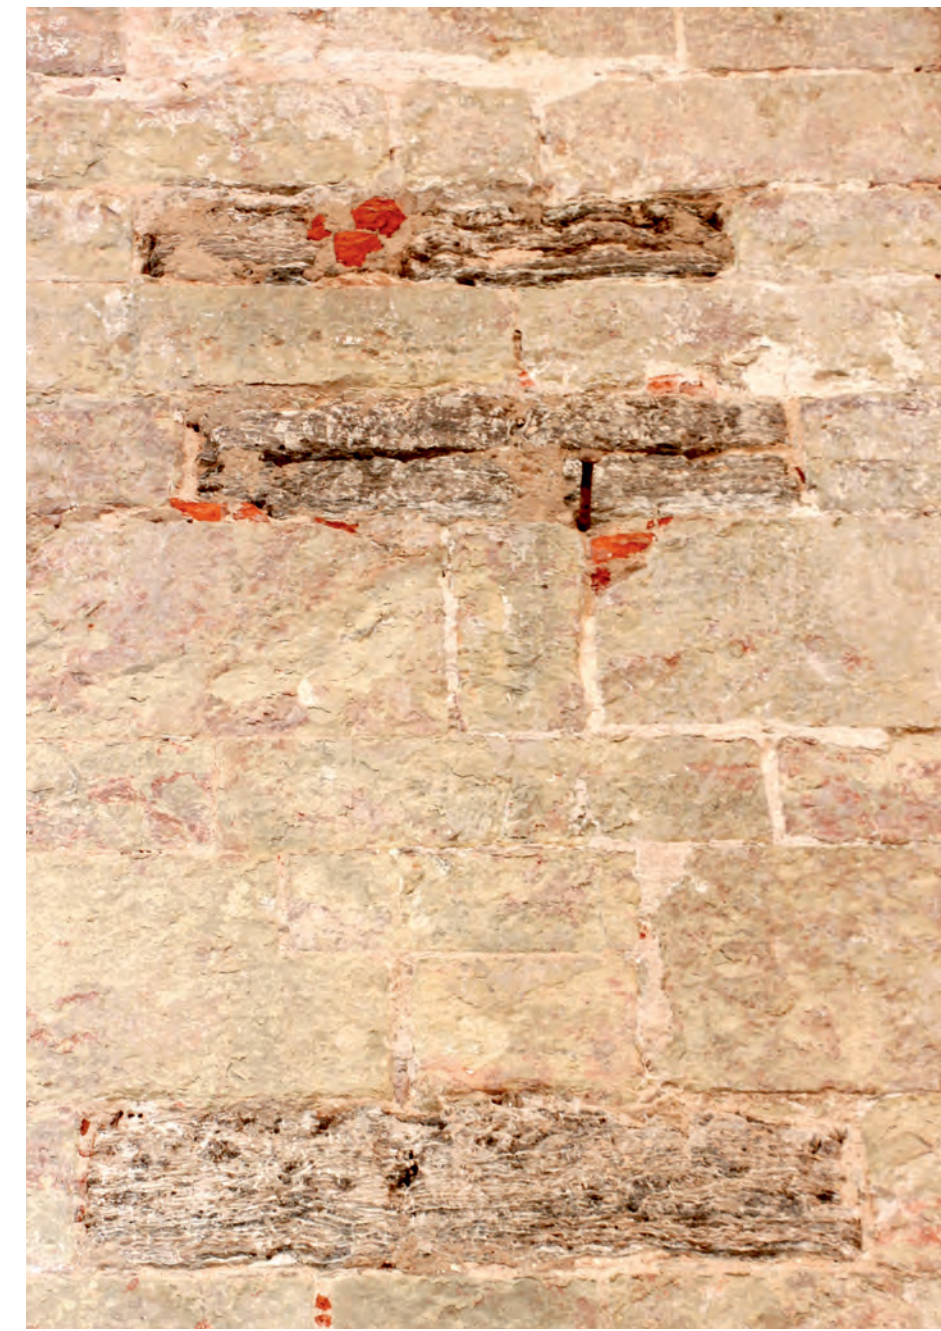
1., 2. Gypsum stone blocks in the Northern wall pilaster of Riga Cathedral, XIII c.

Gypsum stone blocks in the Northern wall of Riga Cathedral is one of the eldest examples of occasional application of gypsum stone. 3 blocks were built in the pilaster of Cathedral at around XIII century (image 1,2). Different types of soluble salts were detected by XRD on the surface of pilaster, coming from diverse sources, but the presence of CaSO₄x2H₂O is related to historically applied gypsum stones [3].

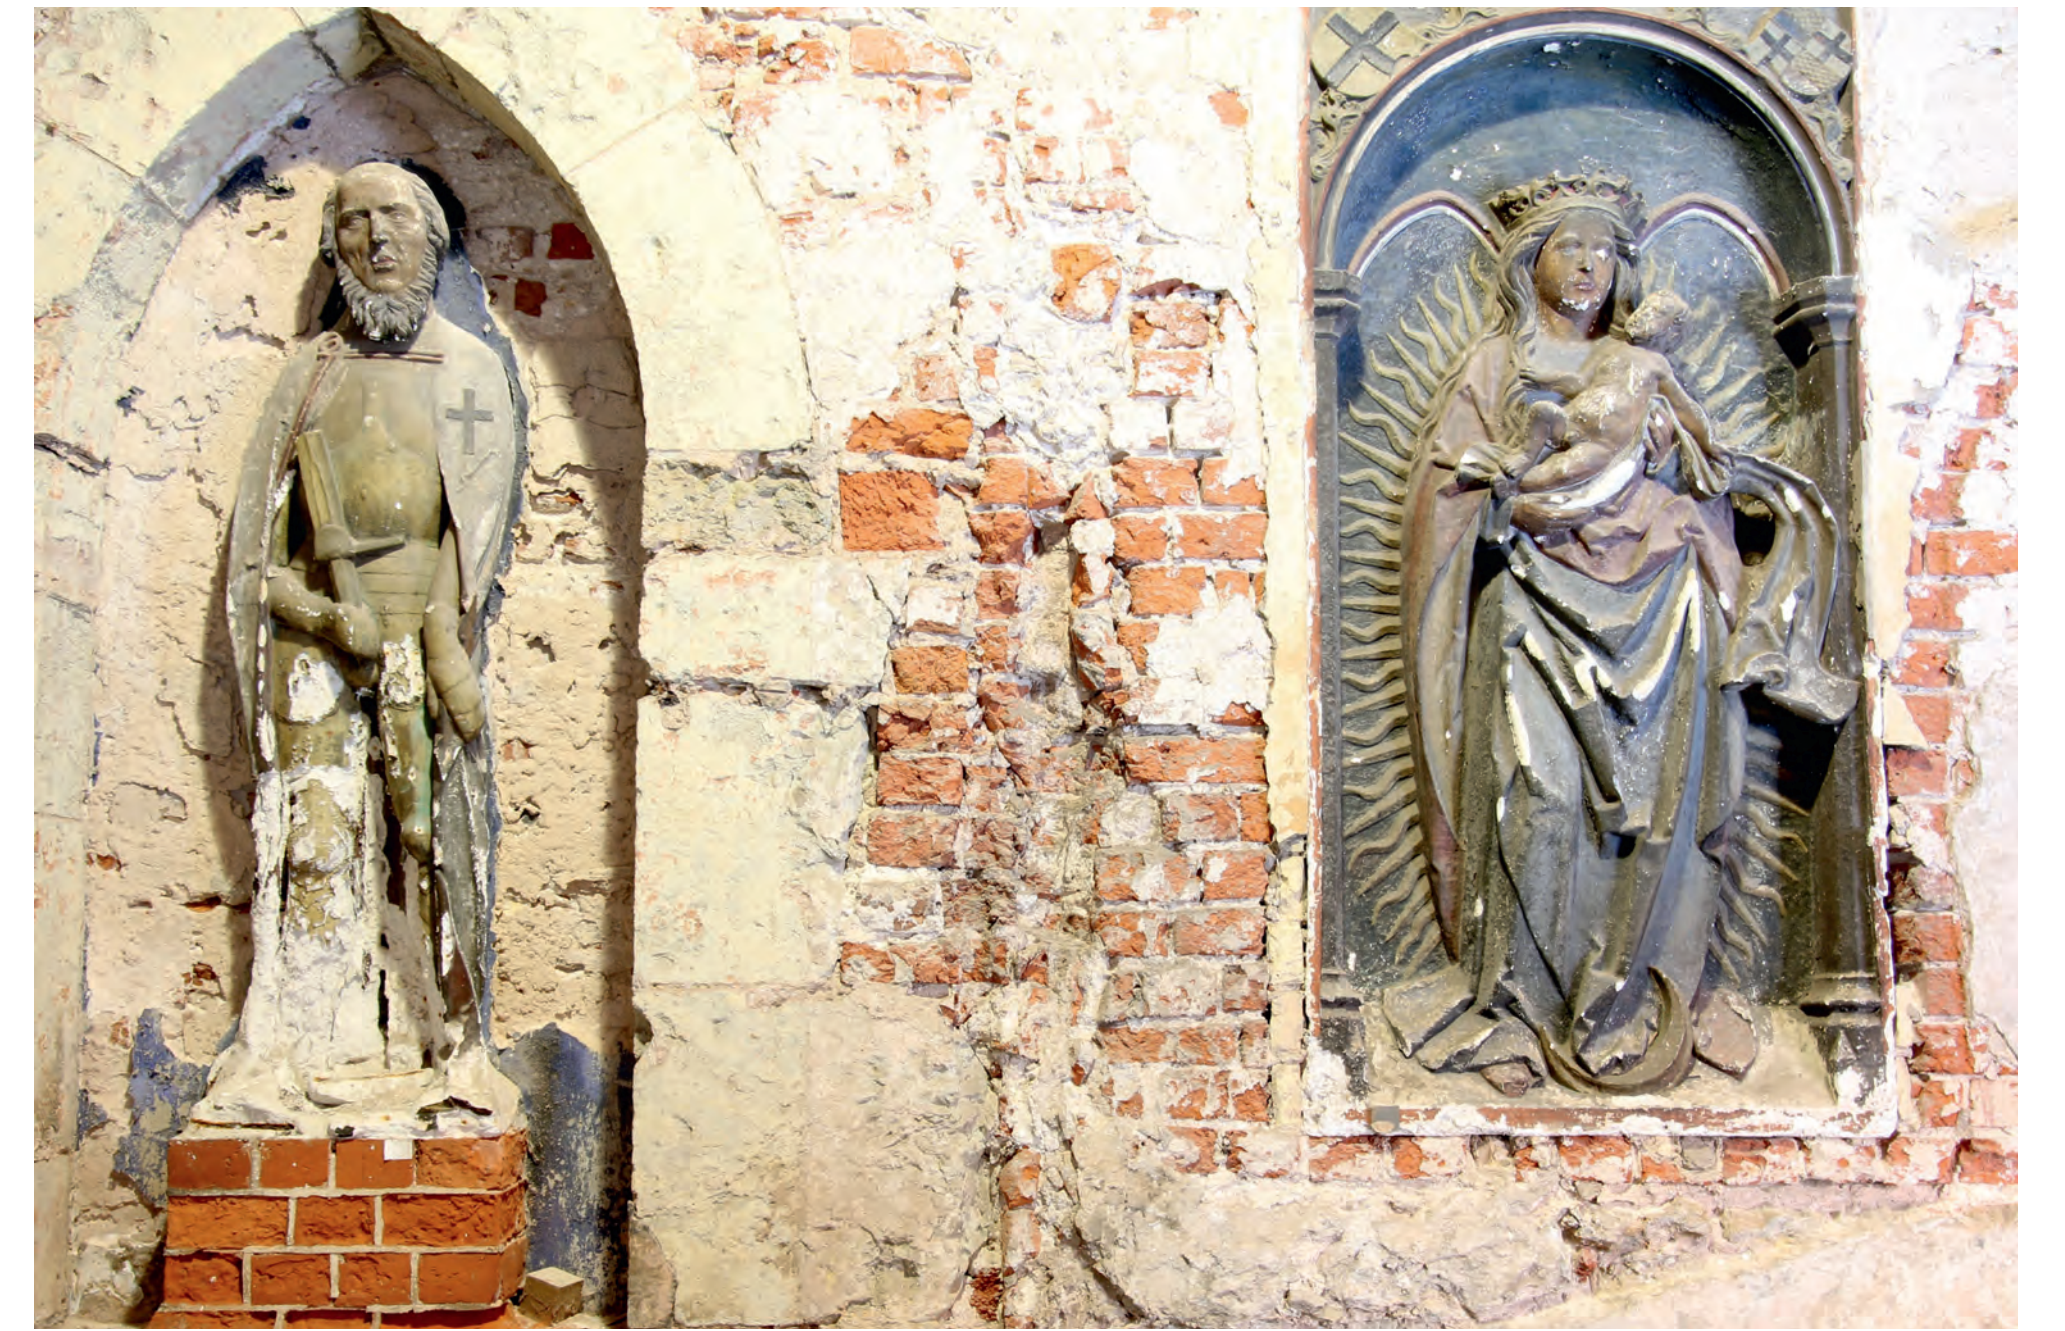
3. Gypsum sculptures of St. Mary and W. von Plettenberg in the Cross-road gallery of Riga Cathedral.

In the crossroad gallery of Riga Cathedral, protected from direct influence of precipitation, there are 2 polychrome gypsum figures – St. Mary and Walter von Plettenberg (image 3). The same sculptures but carved in natural stone in XVI century are in Riga castle as well.

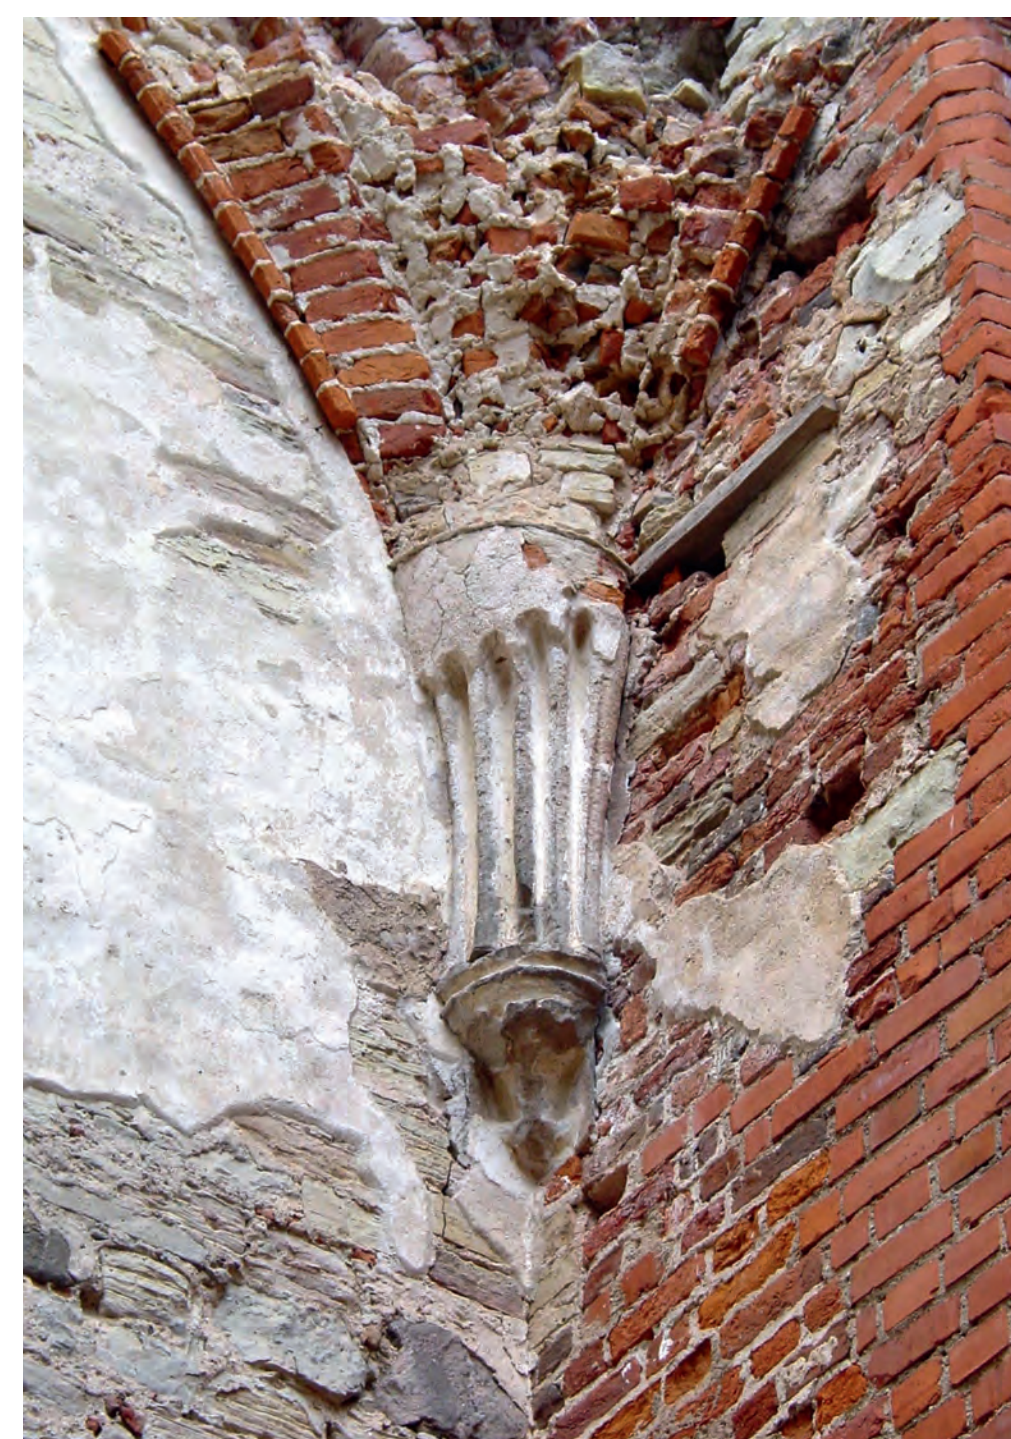
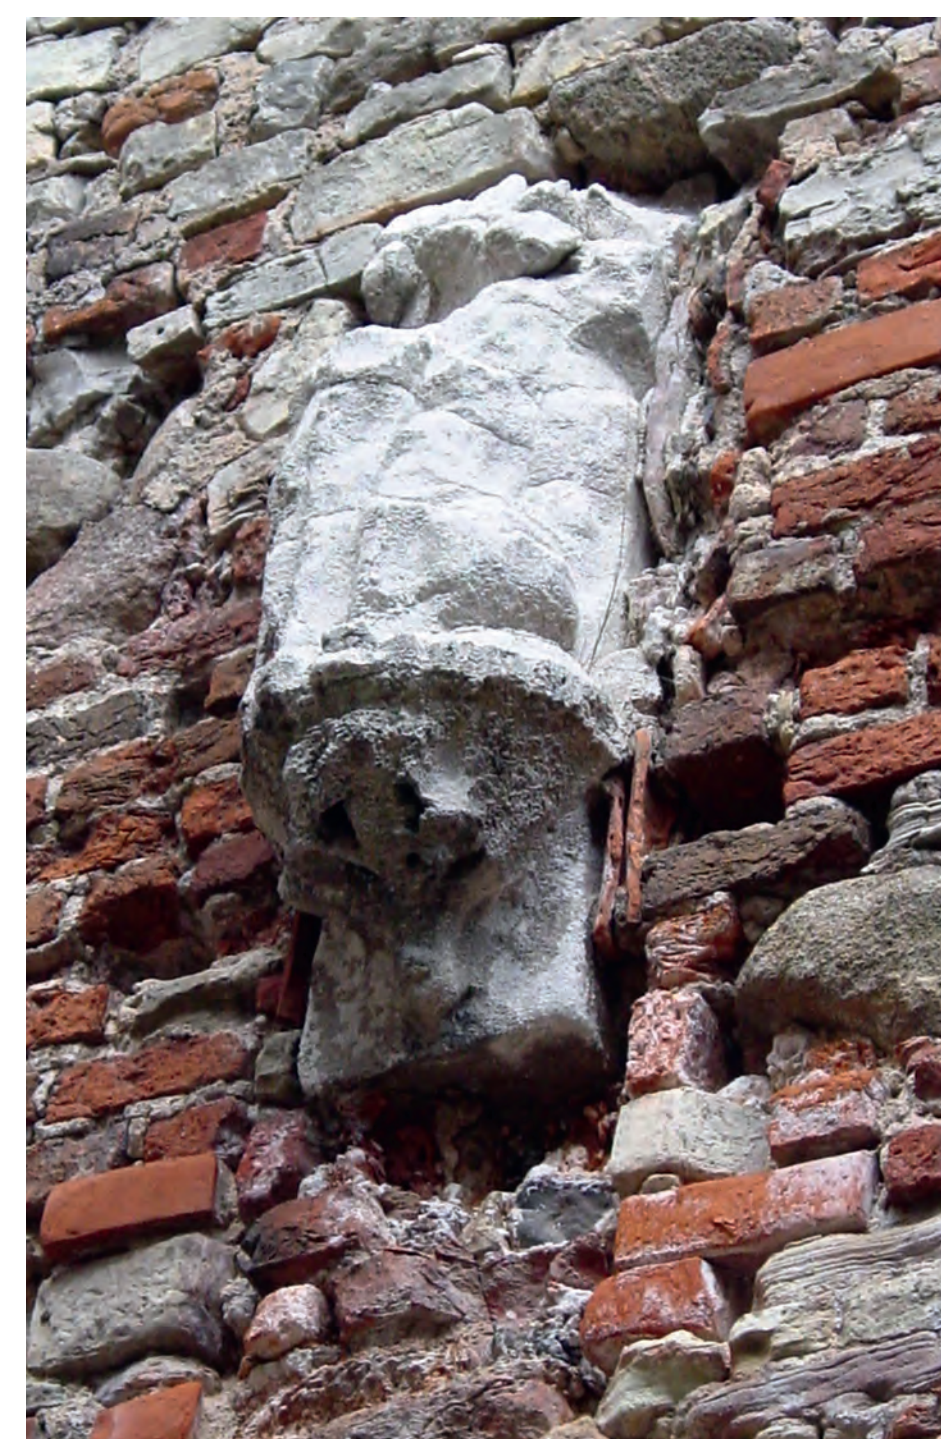
4., 5. Gypsum castings of Cesis medieval castle

In the medieval castle of Cesis, gypsum has been applied for different purposes in the end of XV and XVI century – for decorative castings, mortars and plasters [4]. As with the time the castle turned to ruins, interior become the outdoor space and thus some gypsum elements are exposed to environmental conditions, (image 4,5). As concluded in previous research the gypsum binder for castings, historically was obtained in temperature range of 800-1000° C [5].

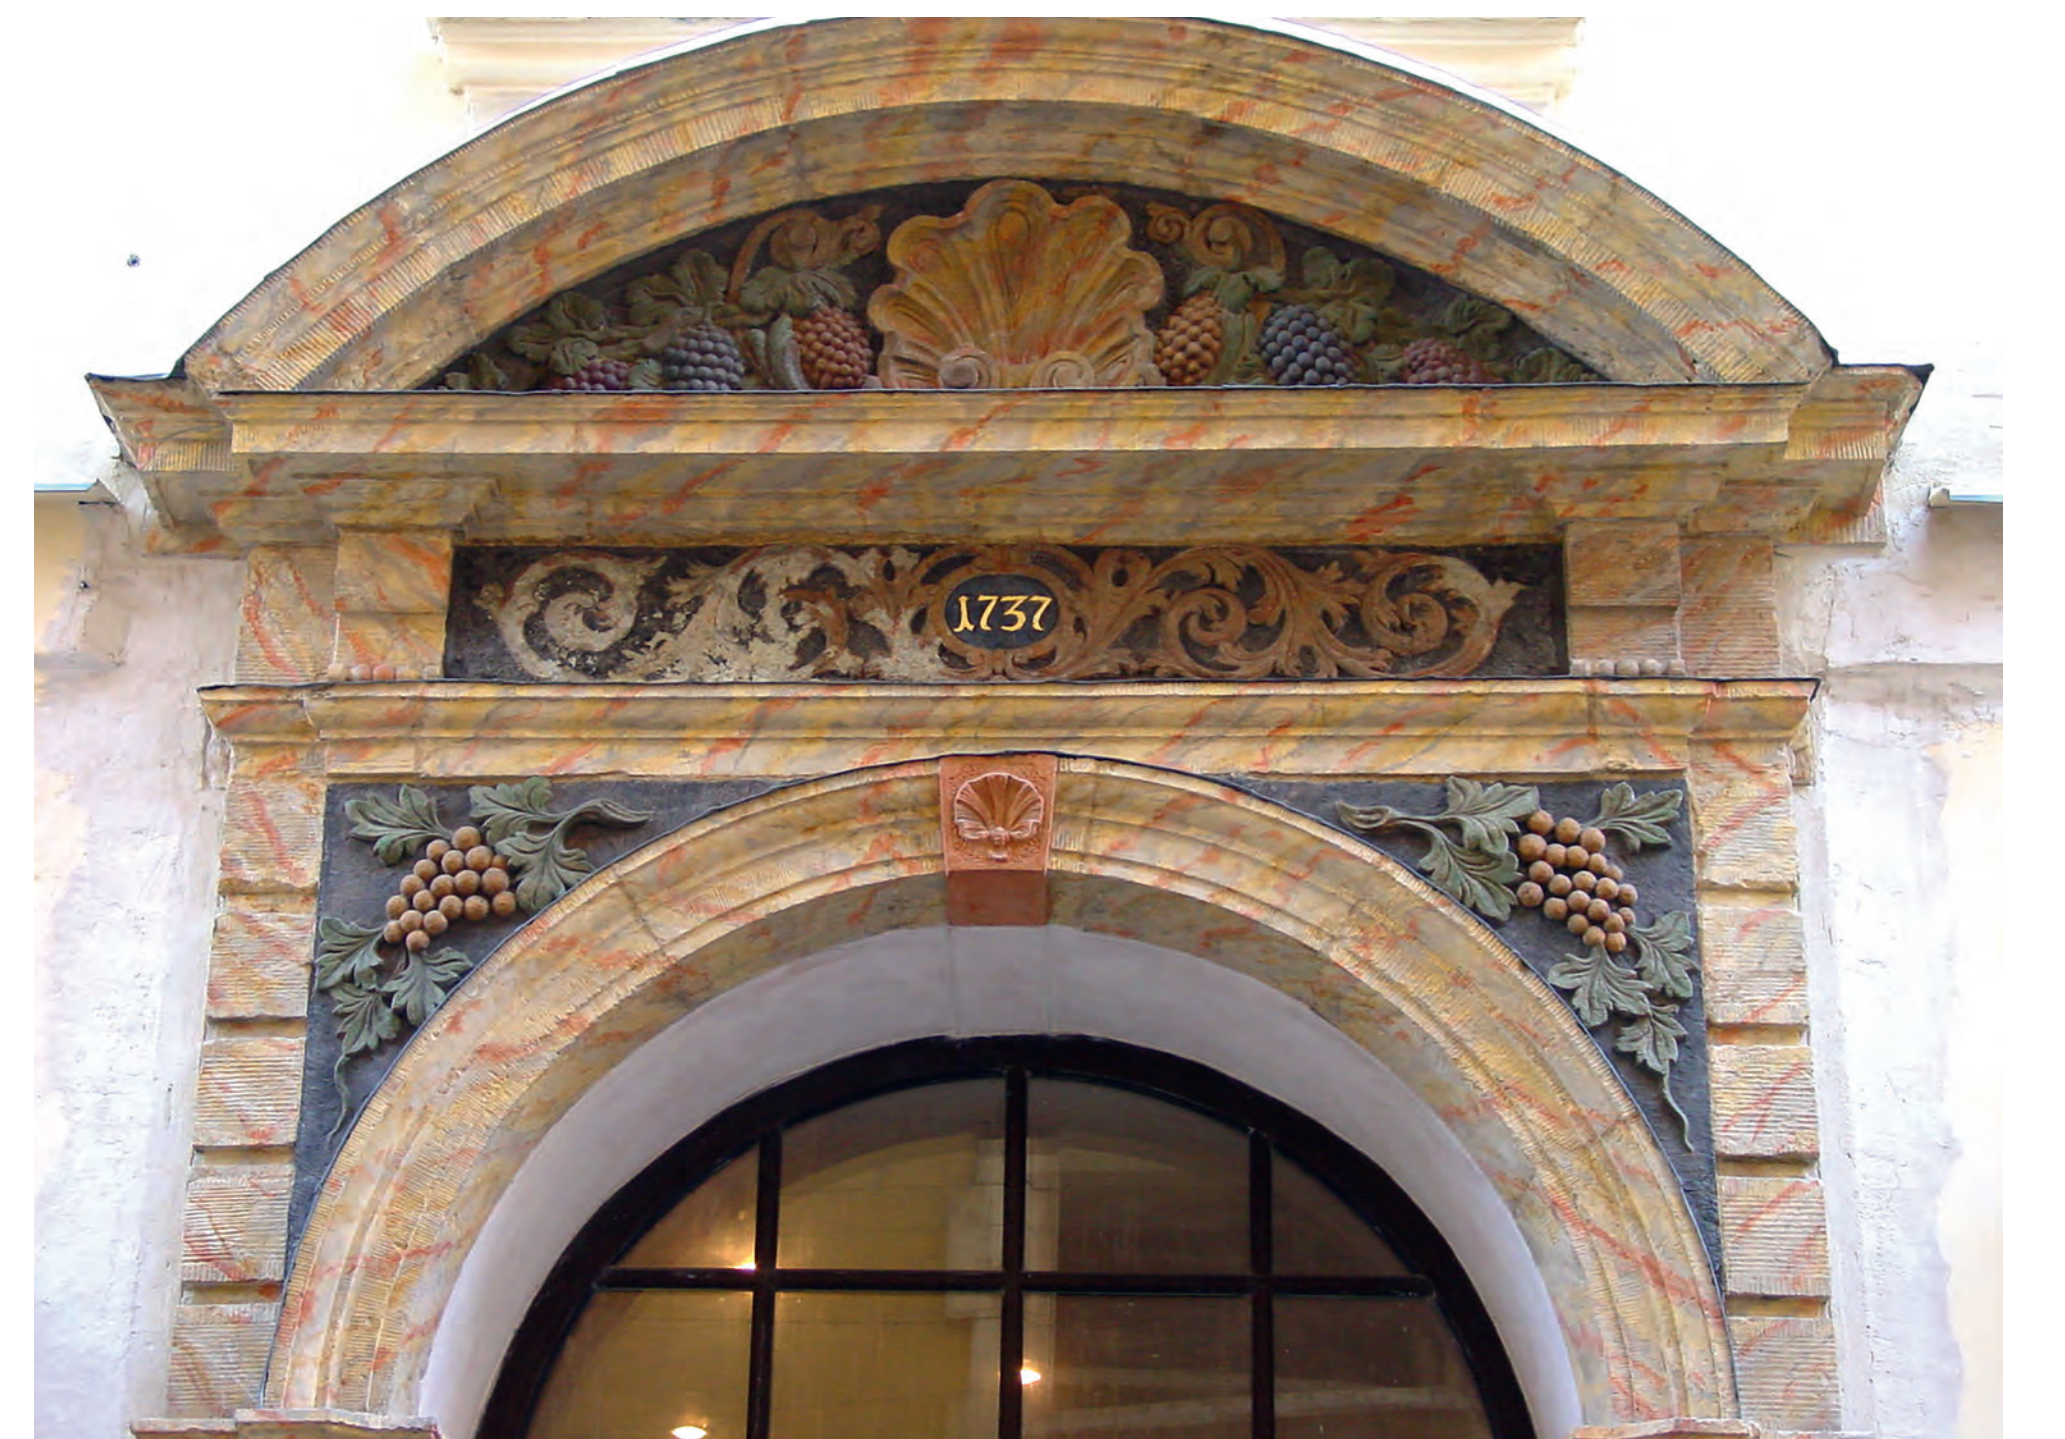
6. Portal in Riga, Kramu str.3, gypsum mortar between the stone blocks during construction, 1737.

The entrance of building in Riga, Kramu str. 3 is decorated with a polychrome portal (image 6), dated with 1737. In the phase of practical conservation (2003-2005), the object was dismantled and removed to restoration workshop, thus the mortars between the parts of portal became accessible. Investigations indicated, that during the construction of object the gypsum mortar was used between the stone parts [6].

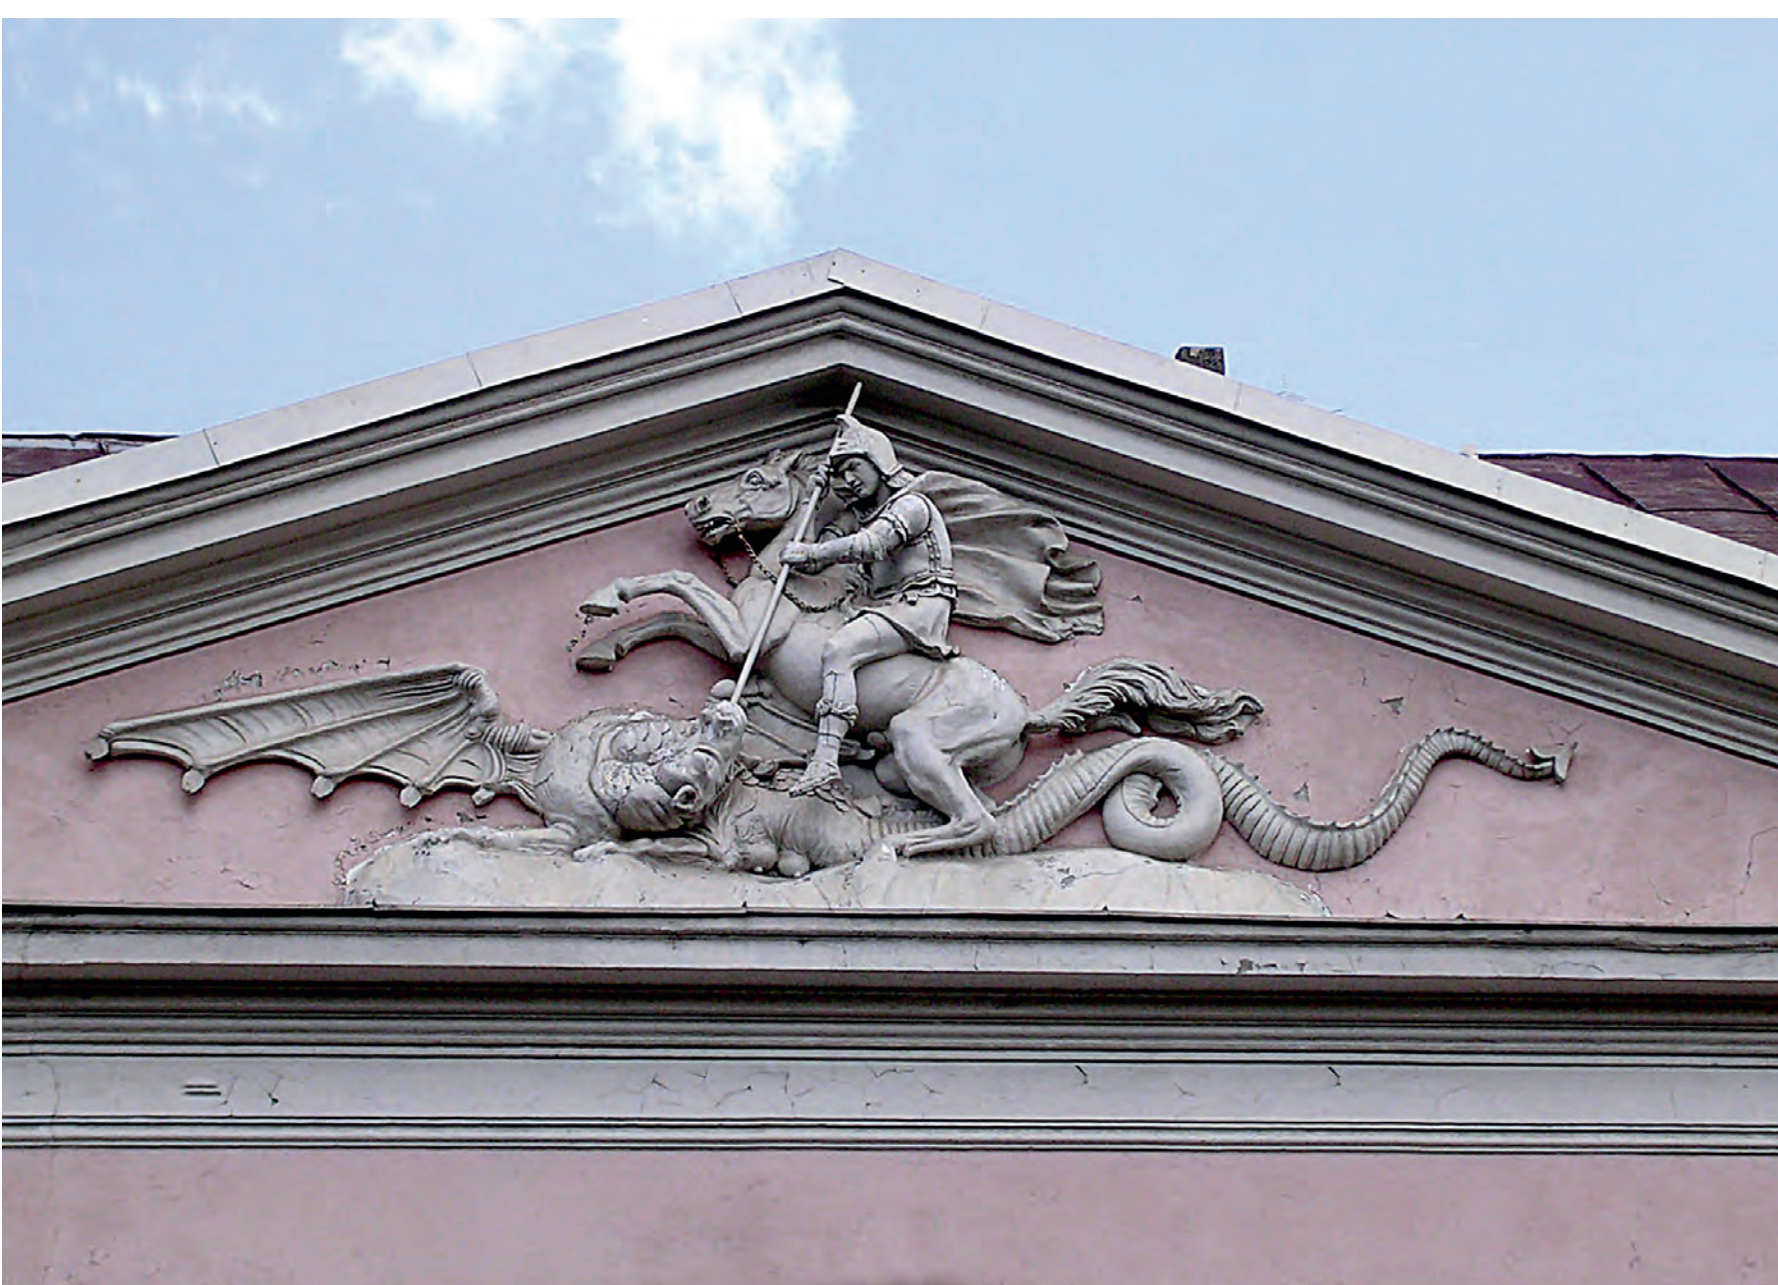
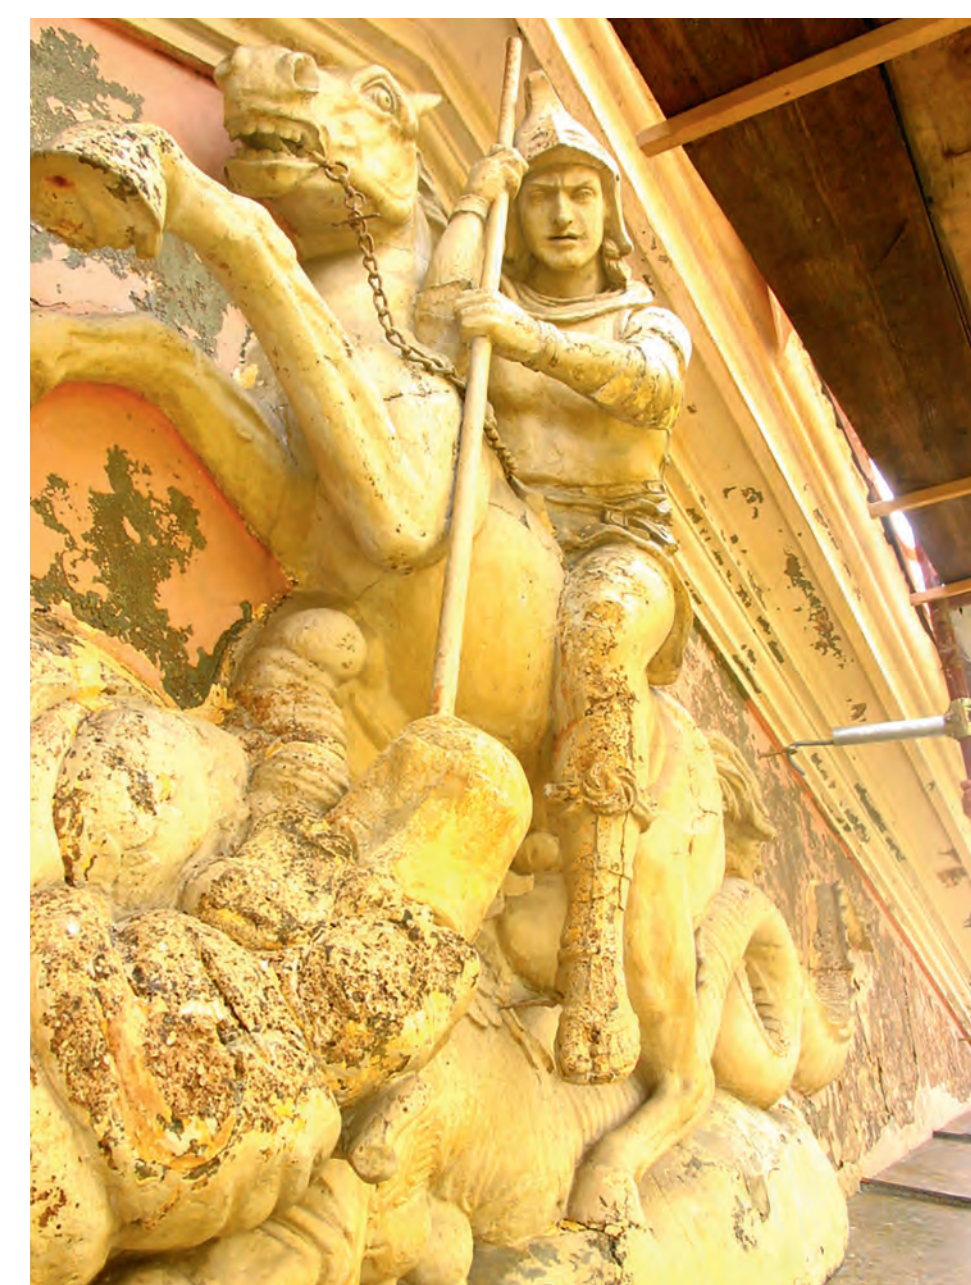
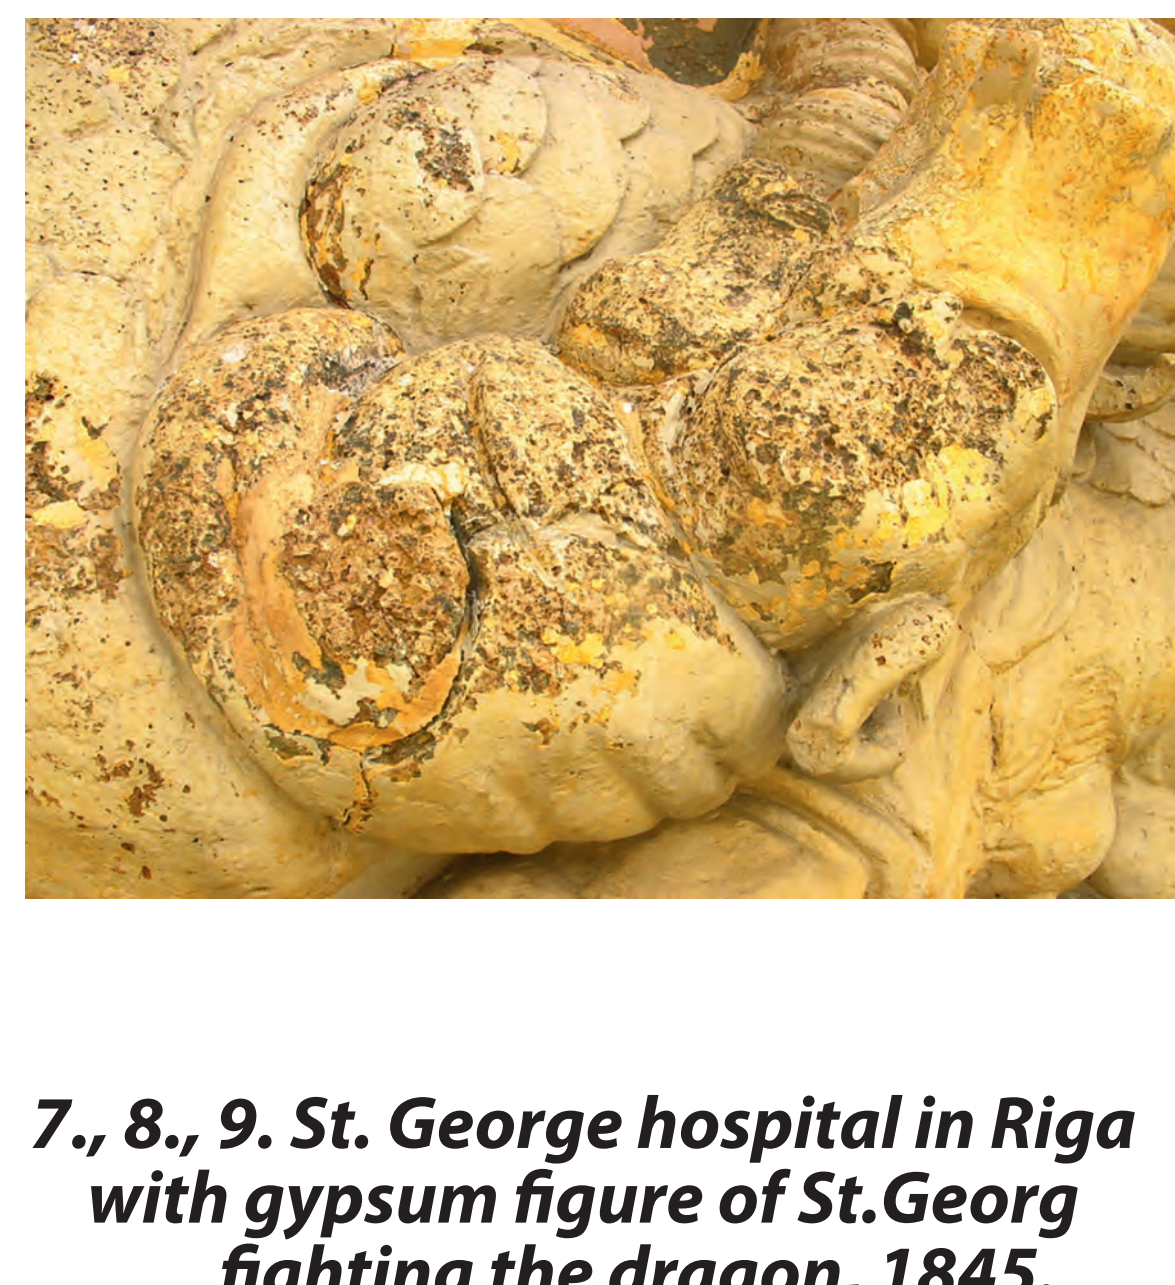
7., 8., 9. St. George hospital in Riga with gypsum figure of St. George fighting the dragon, 1845.

On the facade of the St. George's hospital (1845) in Riga, there is a sculptural group of St. Georg fighting with dragon (image 7, 8, 9). Initially it was thought that the object is carved from freshwater limestone, however DTA/TG analysis indicated that the painted gypsum was used for the creation of object.
