This crucifix is listed as national heritage (Certificate 9348). Author and maker are unknown (maker could possibly come from settlement called Karalauči). Crucifix was initially made for Stende Lutheran Church altar retable in Talsi region. Crucifix was later acquired by Rundāle Castle Museum where it was placed until 2000 when it was moved to Talsi Evangelical Lutheran Church.

Figure of the Christ possibly dates back to the 17th century, but the cross is much younger. Figure of the Christ is made of the linden tree. Cross is made of painted pine. Dimensions of the cross: height 247cm, width 165cm, width of details 15cm, depth of details 3.5cm. Horizontal beam of the cross is sunk into vertical 17cm from the top. Figure: length from toes to fingertips 230cm, arm span 134cm, depth at the height of crown of thorns 29cm.

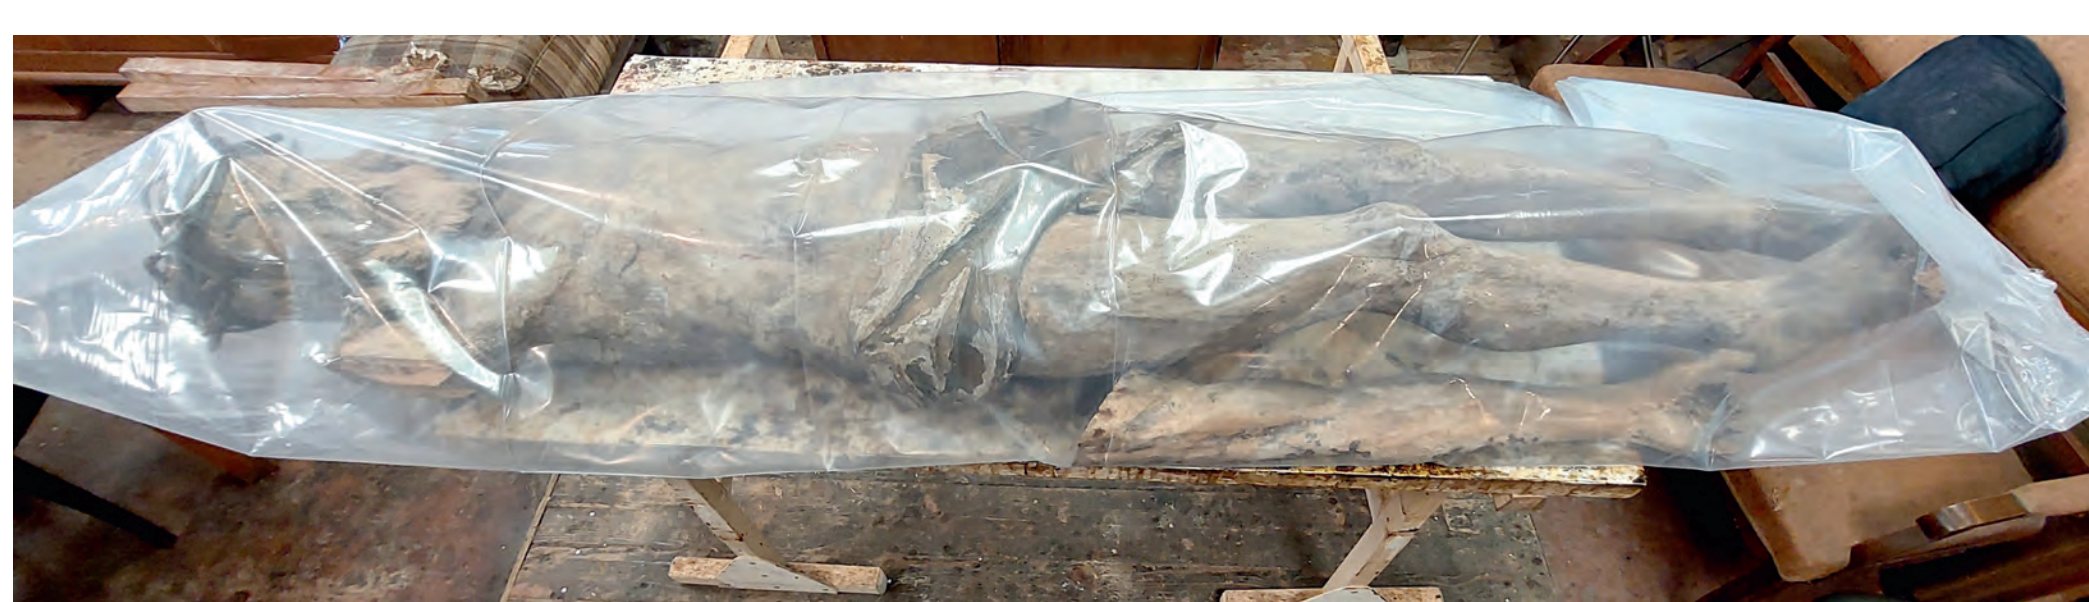
Wood beetles at different stages of development on crucifix
Photo: Aigars Pilenieks

Destruction of wood beetles
Photo: Aigars Pilenieks

Pre-restoration examination of the art piece in the church revealed wide damage caused by woodboring beetles. There was also the visual evidence of continued damage – small pyramid-shaped piles of wood flour had formed in various parts of the figure, especially the head area and feet that had been partially lost. Several species of woodboring beetles were found: *common furniture beetle Anobium punctat* and *beetle Korynetes caeruleus*. Woodboring beetles were extremely lively, they constantly moved up and down the surface of the figure in plain sight.
